# **MLT Ver Codes**

# MLT VER Codes

The purpose of this module is to provide more detail on how to use a combination of VER code, Summary Message, and Test results to make the best decision for the customer and the company. It also provides a Job Aid to help the MLT user access the best possible information about MLT in a VER code listing.

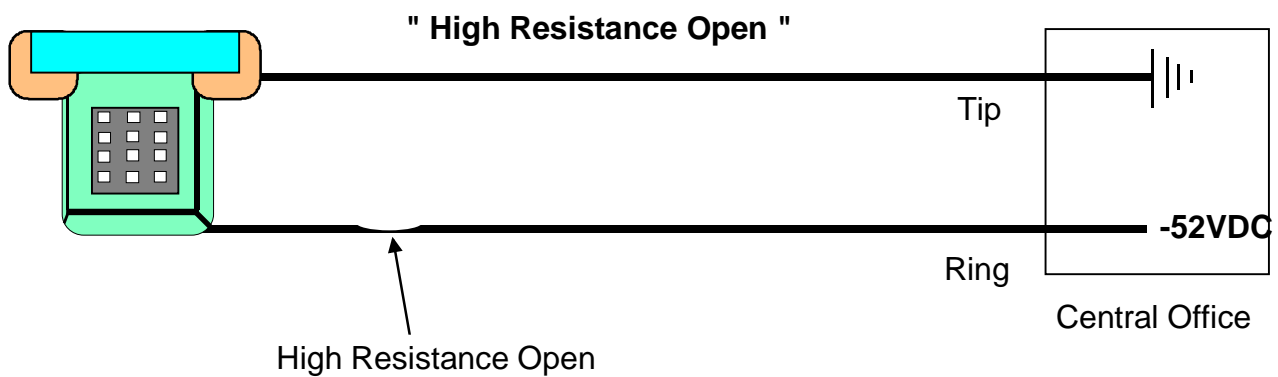
## VER 0C -- CPE or High Resistance Open

The **LEAST** likely line condition with the MLT test result "CPE or High Resistance Open "

**VER 0C -- CPE or High Resistance Open**

MLT did not detect any obvious trouble on the line, however, it did find either a CPE termination or a high resistance open on the line. In most cases this will indicate that it is a CPE termination. The remote possibility exists, however, that it could be a high resistance open problem. **Be VERY reluctant to dispatch a technician on a line that tests CPE OR HIGH RESISTANCE OPEN.**

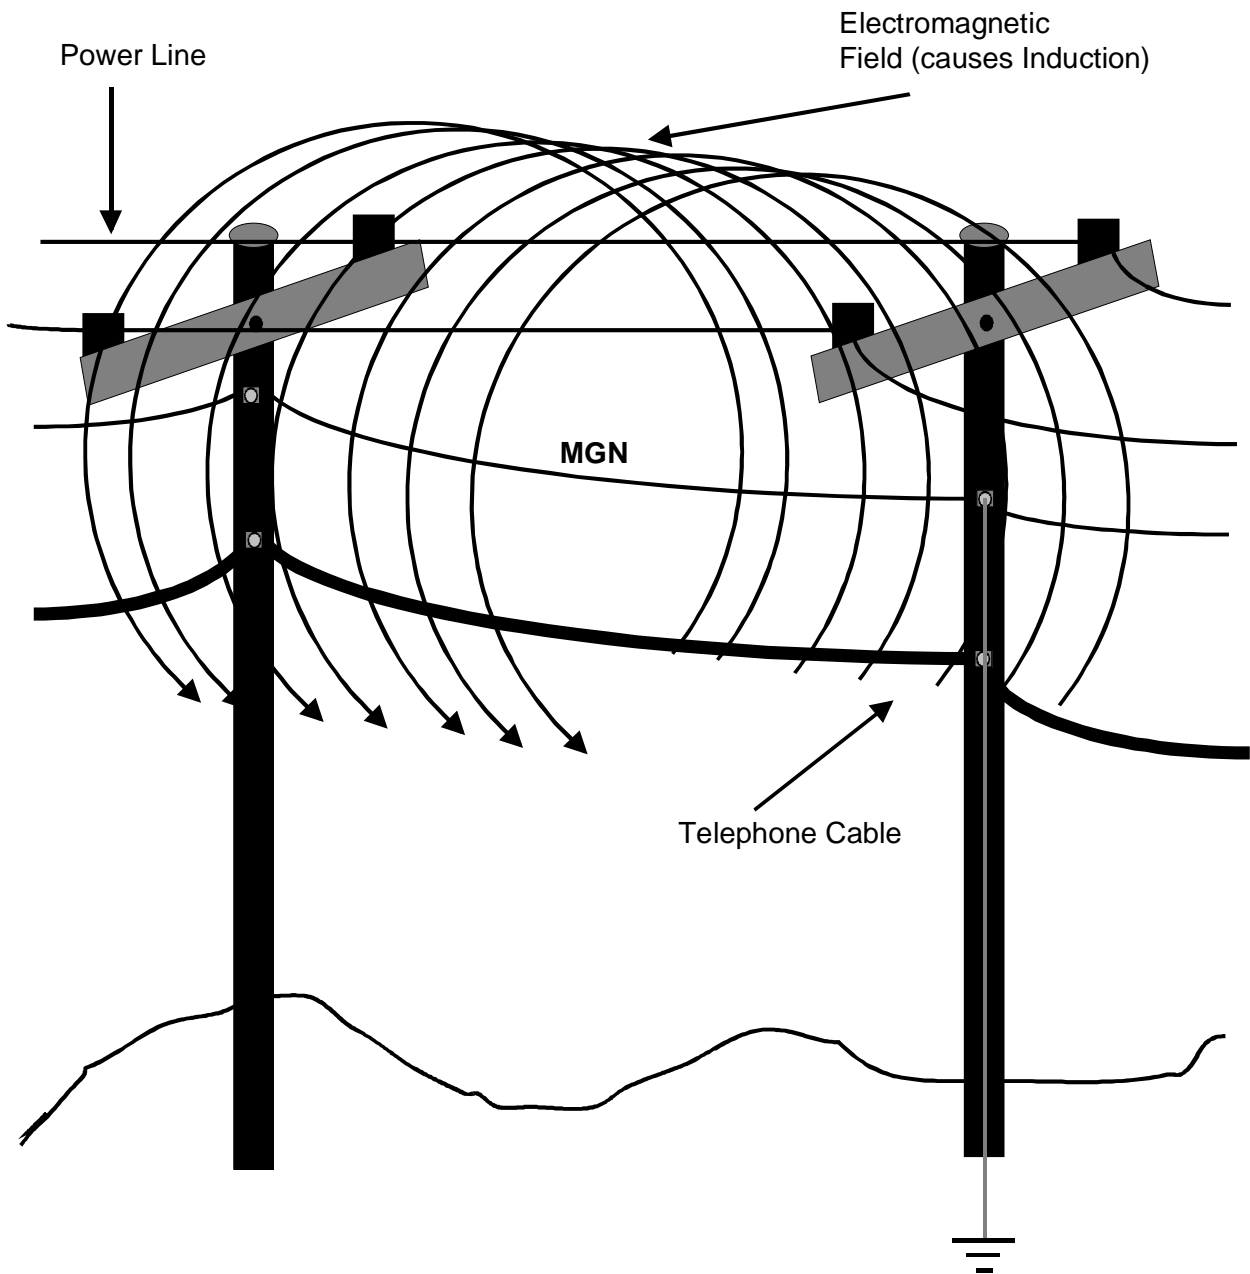
VER 12 -- AC FEMF FAULT

**VER 12 -- AC FEMF FAULT**

An AC foreign voltage greater than the locally determined fault value (25 volts) was detected on the line.

This condition could be caused by a cross with a power line, or AC induction due to telephone lines being close to power lines.

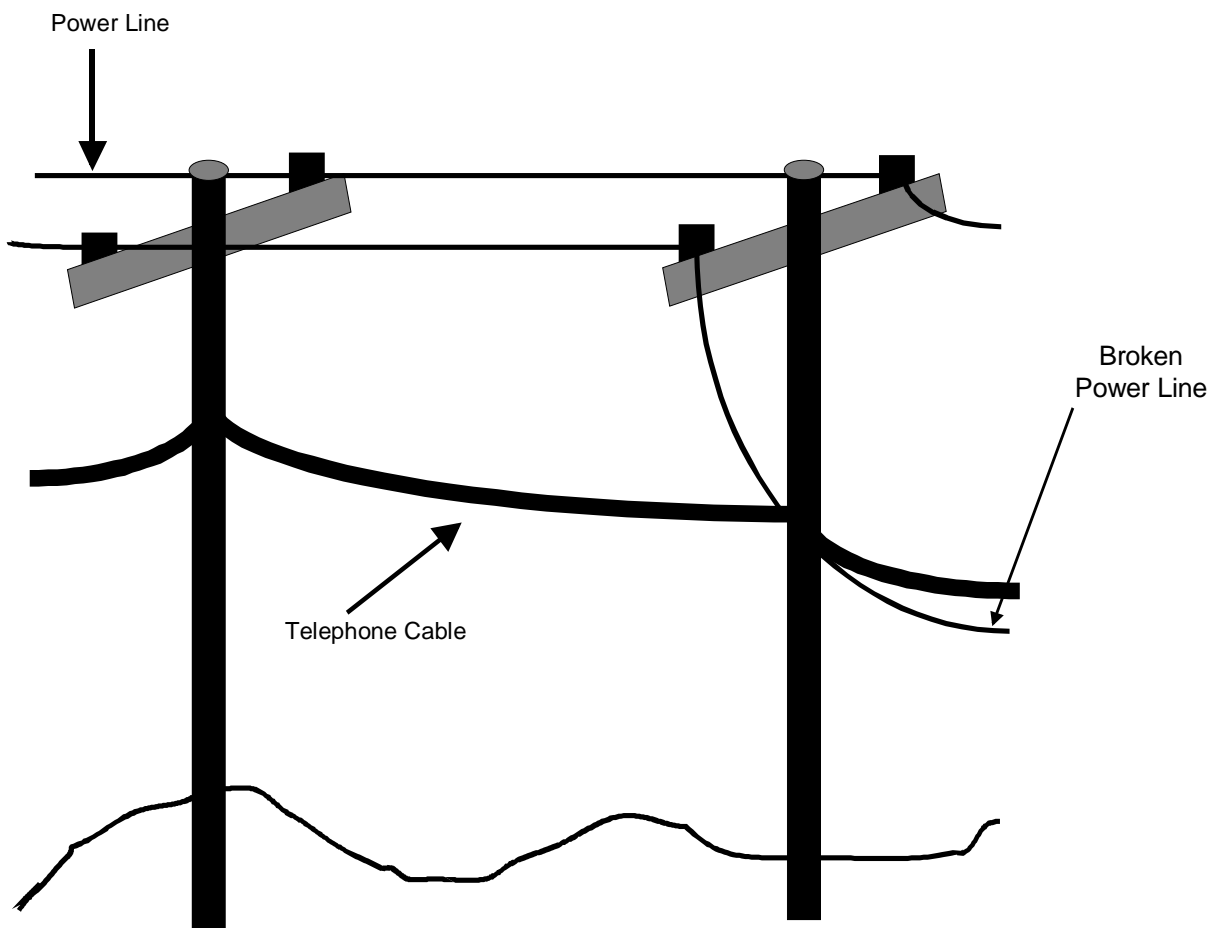
## VER 13 - HAZARDOUS POTENTIAL

VER code 13 is set when, the preliminary MLT tests on the line indicate that there is a **Potentially Dangerous** amount of voltage on the line (150 Volts DC or 50 Volts RMS AC).

Hazardous Potential could be caused by a high voltage surge on a line due to a number of conditions, including a cross with a power line or lightning striking the line. The MLT equipment will remain attached to the line, but all further test requests will only check to see if the hazardous potential is still present.

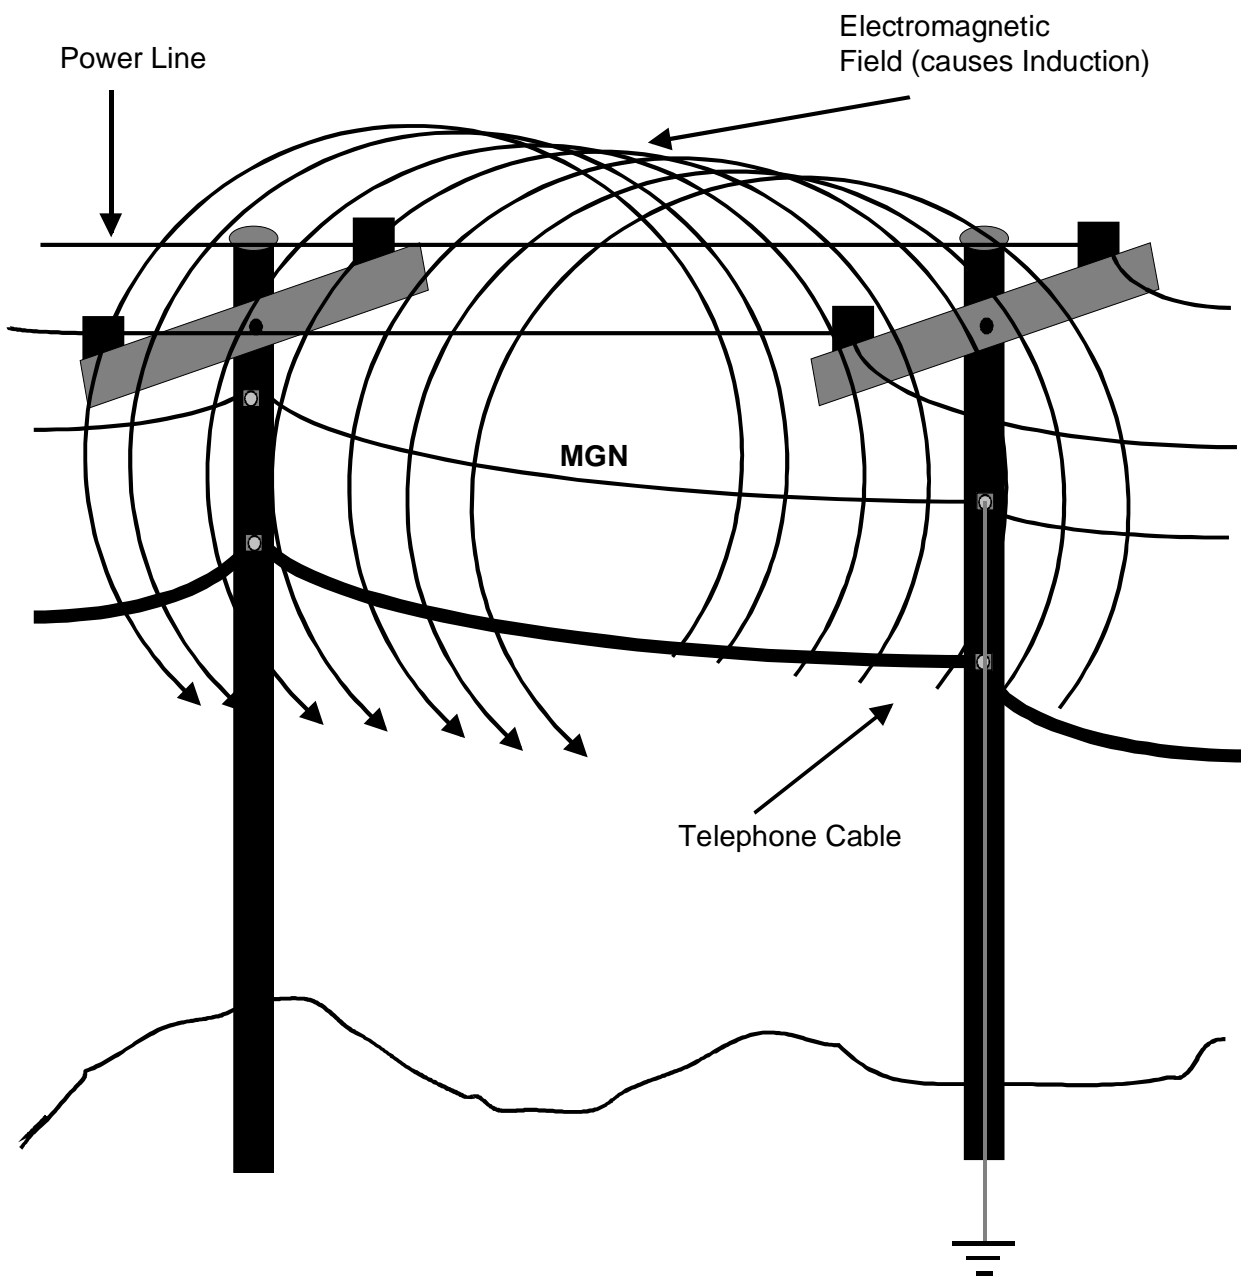
VER 16 -- AC FEMF MARGINAL

An AC FEMF (Foreign Electromotive Force) or voltage less than 25 volts but greater than the display threshold of 15 volts.

This condition could be caused by a cross with a power line, or by AC induction due to the close proximity of telephone lines and power lines.

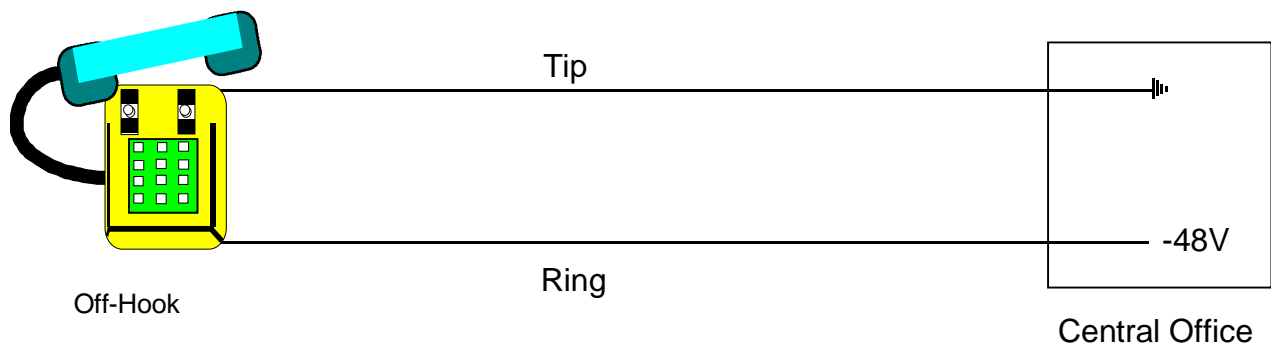
This line, if tested soon after the customer went off-hook, may test VER 17.

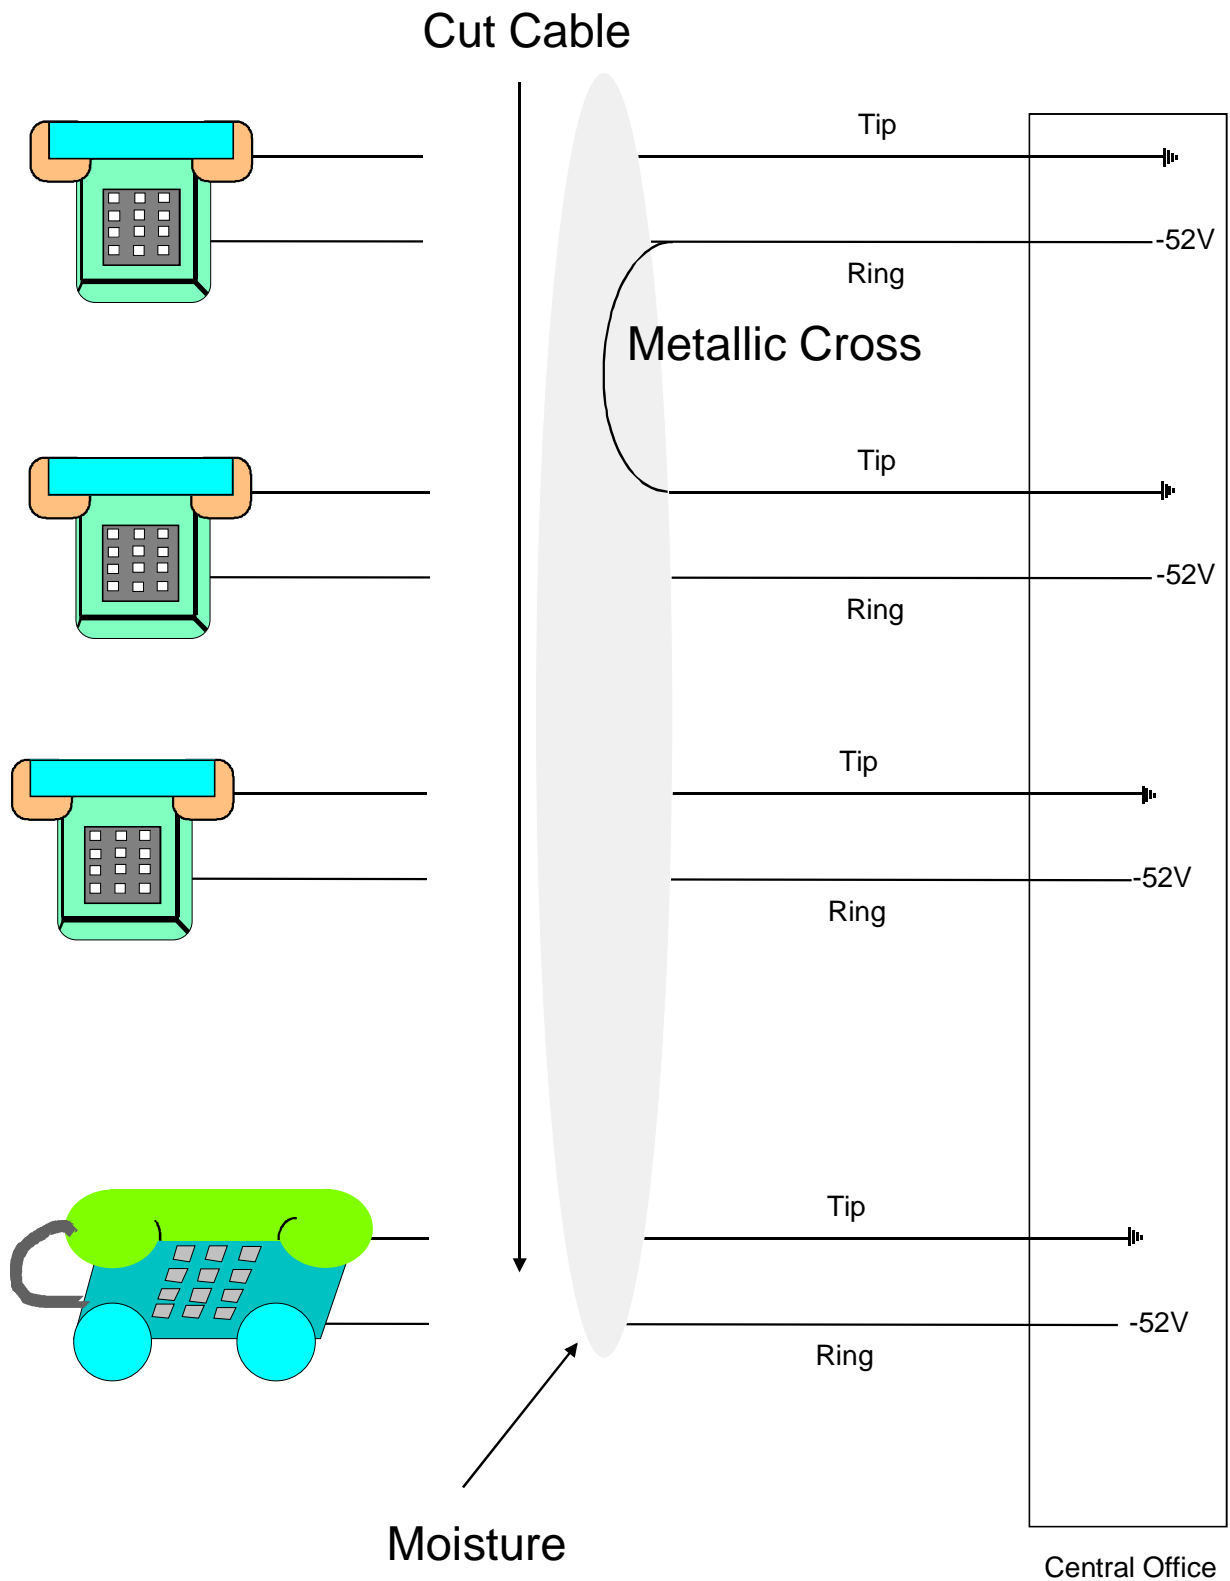
## VER 18 -- OPEN OUT AND CROSS

MLT has detected an open on the line and has determined that the open is out of the CO. In addition, a cross to a working pair has been detected.

Usually, when there is more than one trouble on the line, they are related in some way. One likely situation is that there is an open in the cable and the open wires in the cable are crossed. Here the open is causing the cross to working pair condition.

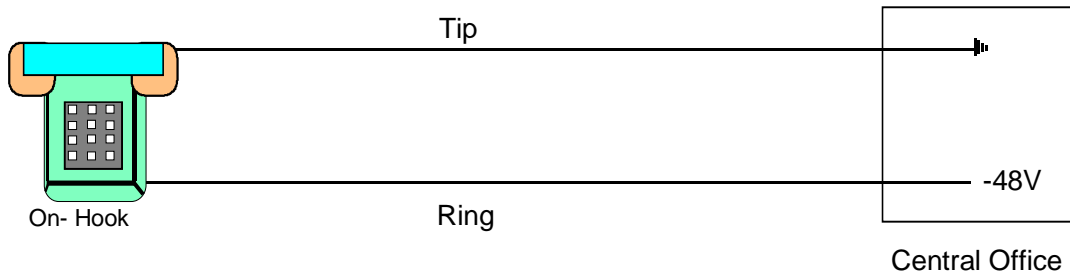
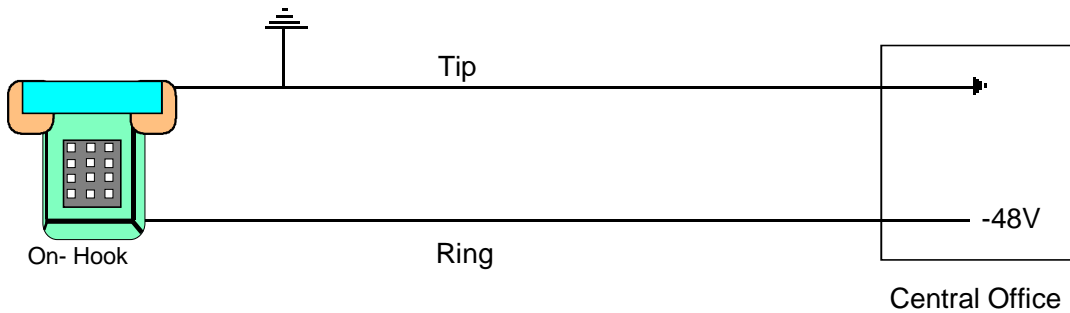
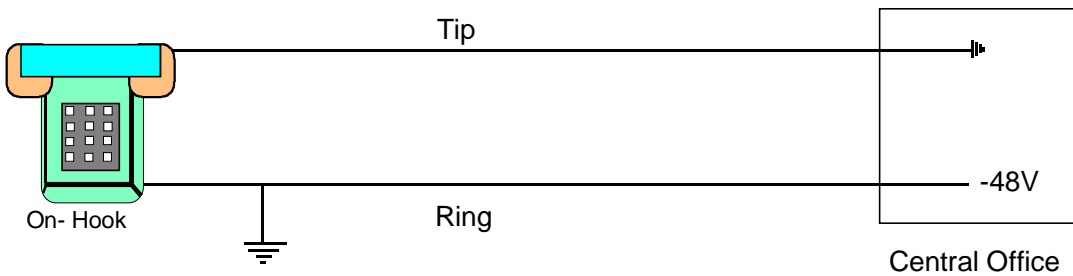
**VER 21 -- GROUND FAULT****Test Okay**

**Tip Ground**

**Ring Ground**

**Tip and Ring Ground**

The condition indicates that the MLT DC RESISTANCE to ground (ring-ground and/or tip-ground) is below 150 KOHMS. On a normal line the MLT DC RESISTANCE to ground is high (usually 3500 K ohms). MLT expects it to be more than 1000 KOHMS.

A ground condition can be caused when the insulation between wires of a pair is worn down and the wires either come in contact with or establish an electrical path to a grounded object. Most grounds occur outside of the central office. You can assume that the ground is out of the central office on an MLT VER 21. When the resistances are very low, the trouble may be in or out of central office. MLT, however, realizes this and in such cases recommends that you run an MDF test to sectionalize the trouble.

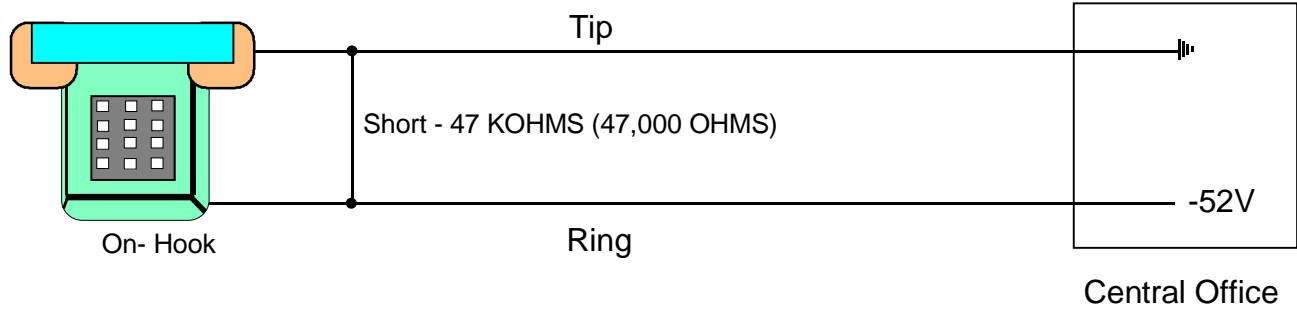
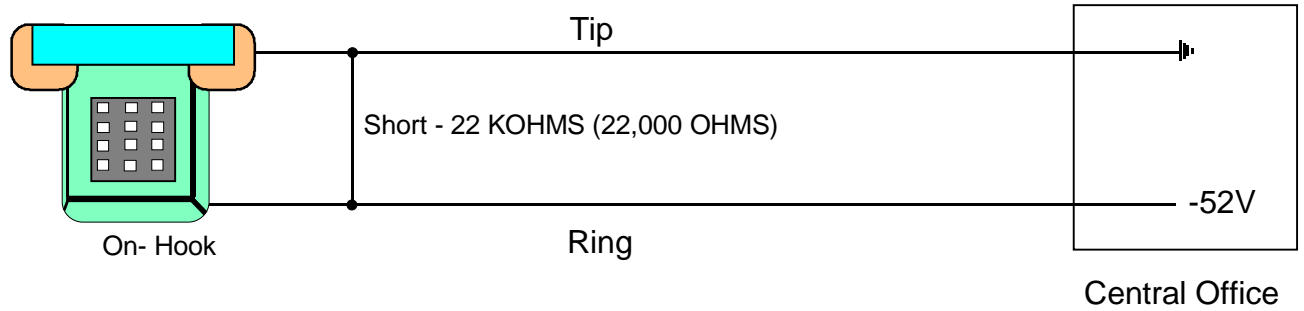
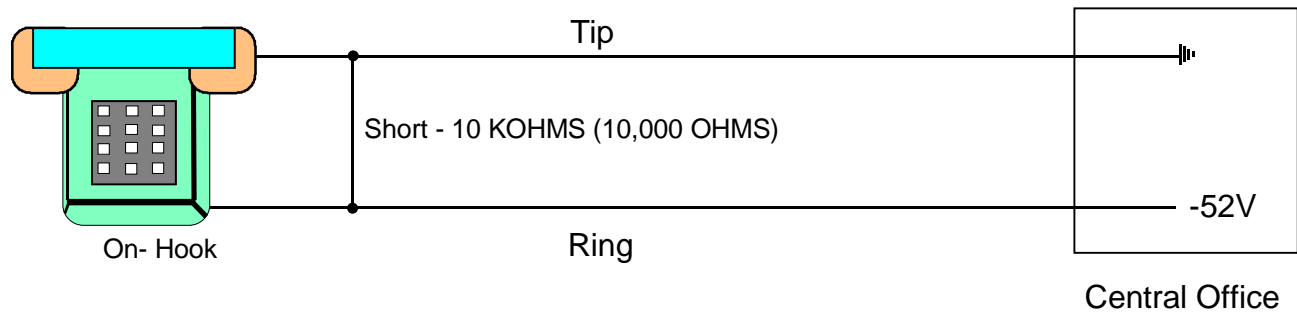
**VER 22--SHORT FAULT**

This condition indicates that the MLT DC RESISTANCE tip to ring is below 150 KOHMS. On a normal line the MLT DC RESISTANCE tip to ring is high (usually 3500 K ohms). MLT expects it to be more than 1000 KOHMS.

A short condition can be caused when the insulation between wires of a pair is worn down and the wires either come in contact with or establish an electrical path with each other. Most shorts occur outside of the central office. You can assume that the short is out of the central office on an MLT VER 22. When the resistances are very low the trouble may be in or out of central office. MLT, however, realizes this and in such cases recommends that you run an MDF test to sectionalize the trouble.

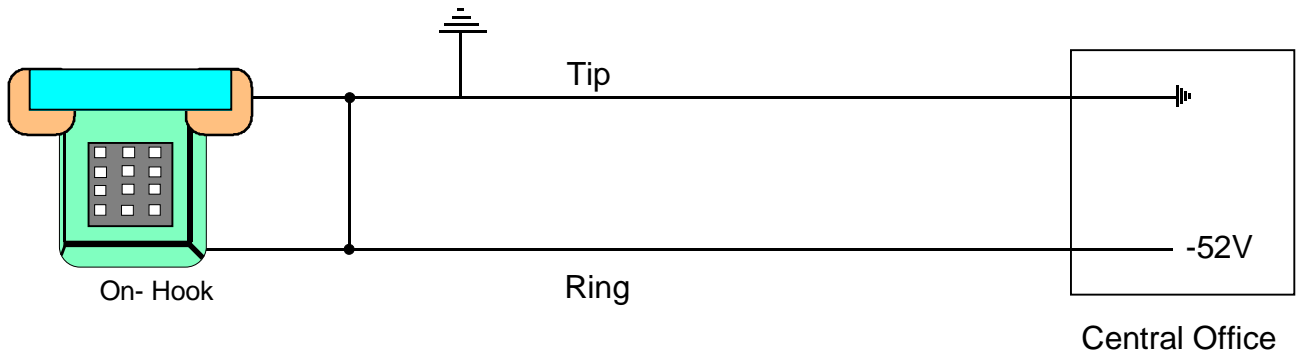
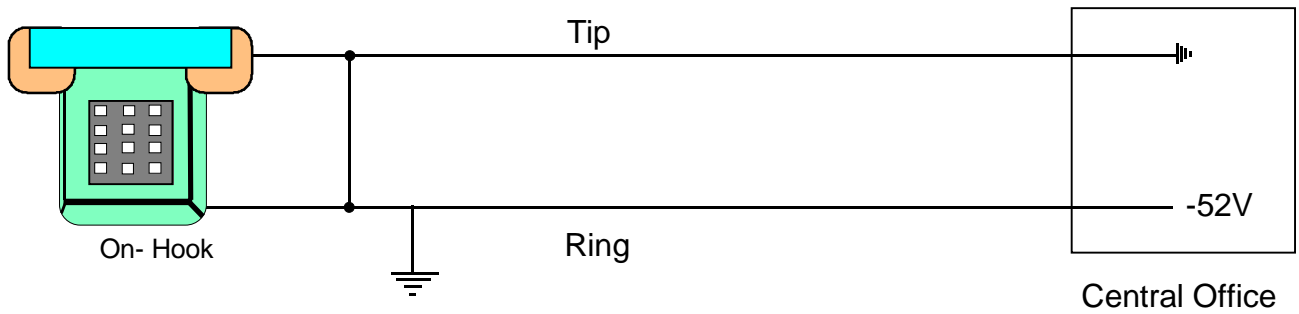
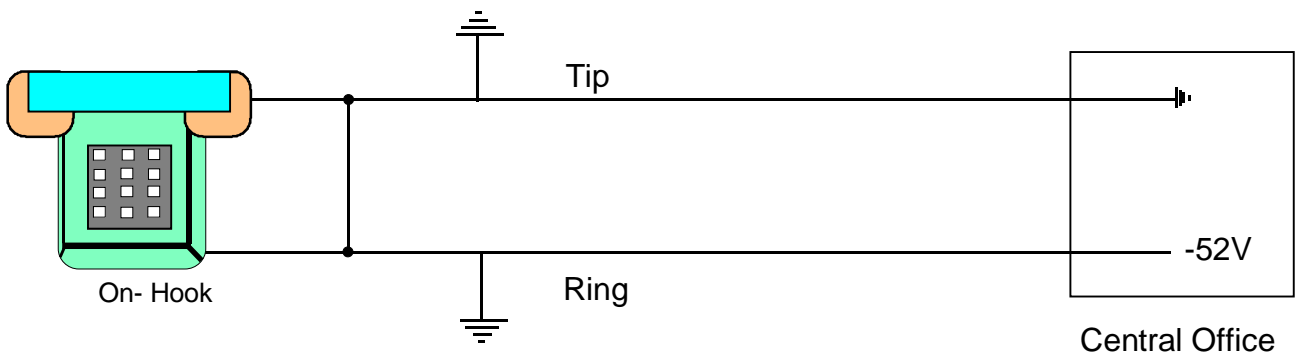
**VER 25 -- SHORT AND GROUND**

Short and Tip Ground

Short and Ring Ground

Short, Tip and Ring Ground

This VER code indicates that MLT has detected a short fault (DC resistance tip to ring below 1000 KOHMS). In addition, one or both of the ground DC resistances (T-G or R-G) was below 1000 KOHMS. On a normal line all the MLT DC resistances should be high (usually 3500 KOHMS).

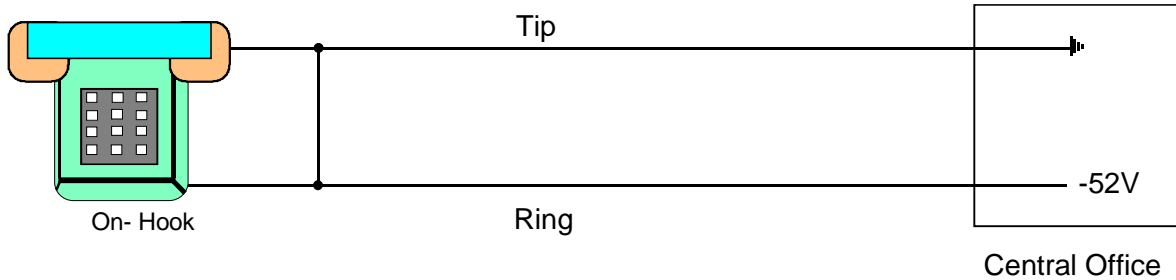
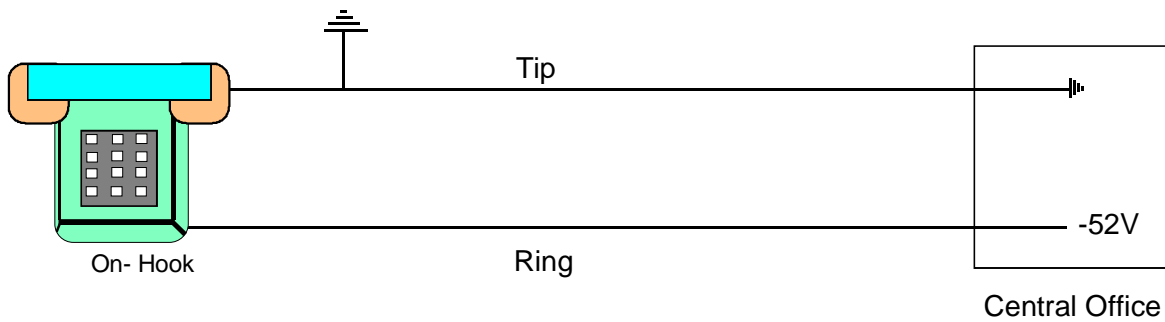
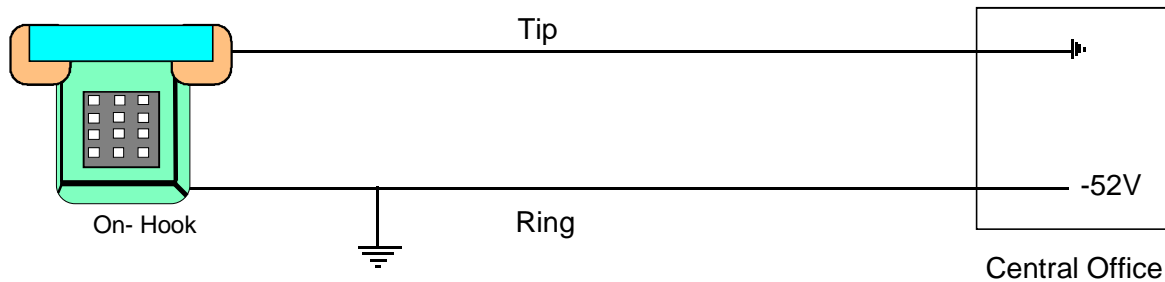
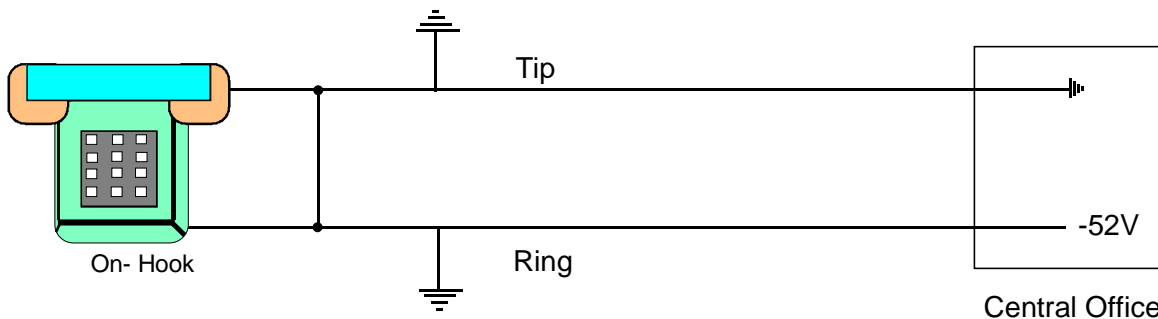
## VER 27 -- DC RESISTANCE - MARGINAL

## Shorts and/or Grounds with Resistances Above 150 KOHMS

This VER code indicates that MLT has detected a short or a ground condition and the MLT DC RESISTANCE was above 150 KOHMS, but below 1000 KOHMS. This is a marginal condition and will not be described a fault. On a normal line the MLT DC resistances should be high (usually 3500 KOHMS).

In the example above, the SHORT is not a very severe problem; it is marginal (note the summary message LIGHT SHORT). Repair technicians may have a more difficult time locating the trouble since it is only a marginal one.

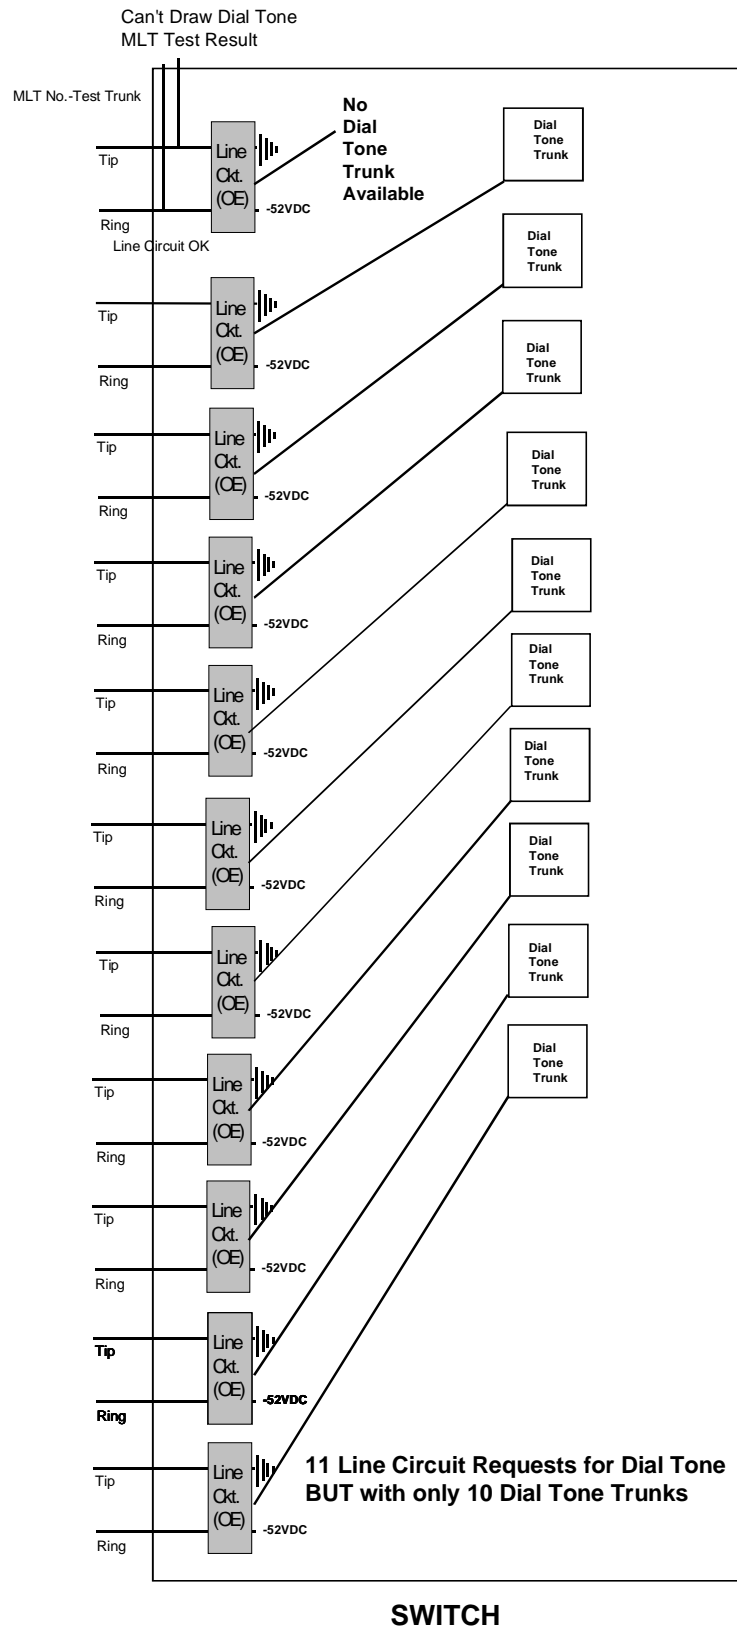
## VER 32 -- CAN'T DRAW DIAL TONE

MLT attempts to draw and break dial tone after it checks the central office line circuit. In this VER condition, MLT was not able to draw dial tone within the allotted 6 second interval. The MLT user should not dispatch this VER code until it has been re-tested with the same result. It is often the result a Central Office overload. An example of a possible situation that could cause this test result is shown on the facing page.

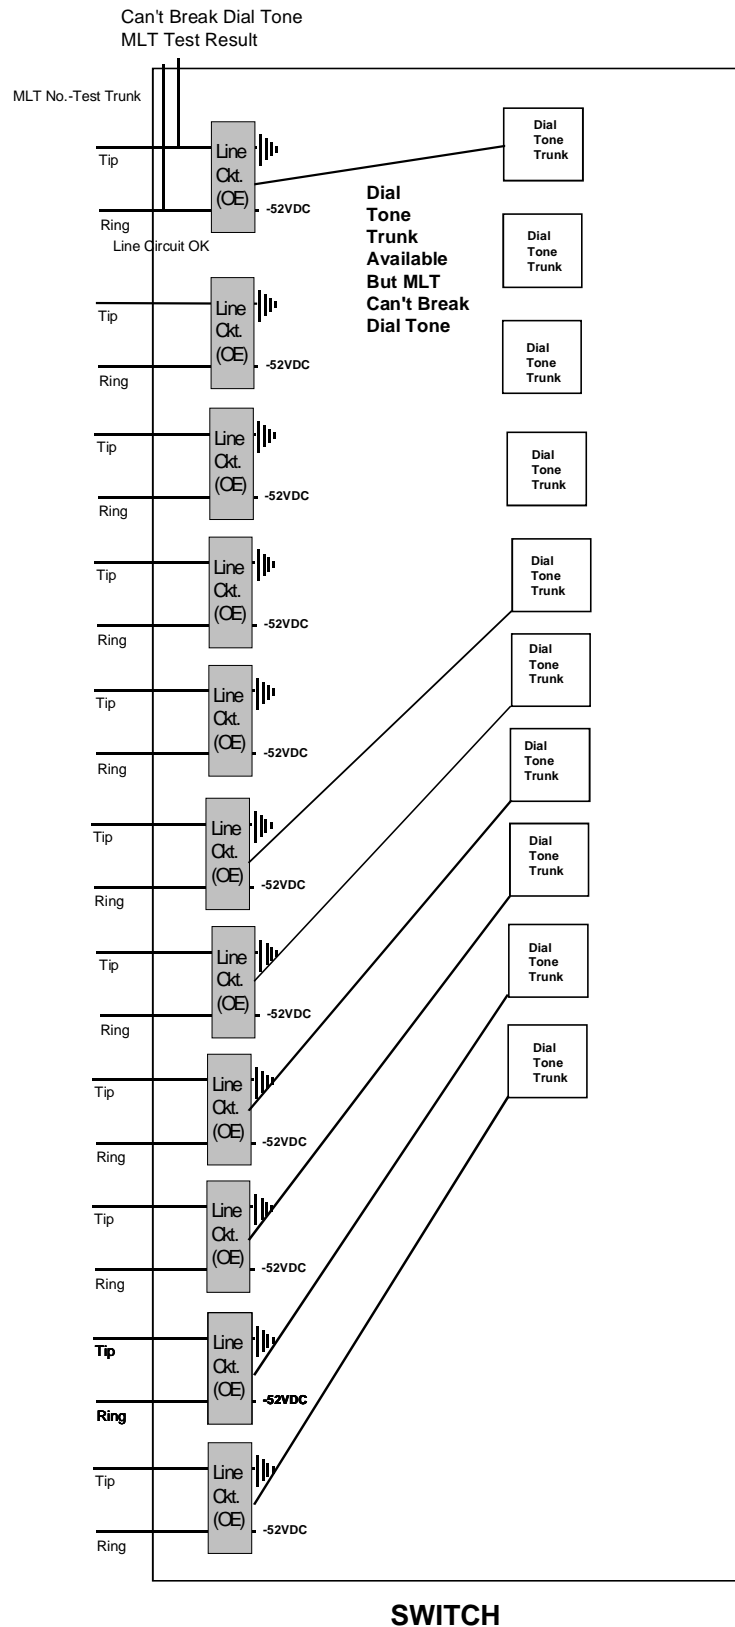
## VER 33 -- CAN'T BREAK DIAL TONE

MLT attempts to draw and break dial tone after it checks the central office line circuit. In this VER condition, MLT was able to draw dial tone within the allotted 6 second interval, but it was not able to break dial tone within the 1 second interval.

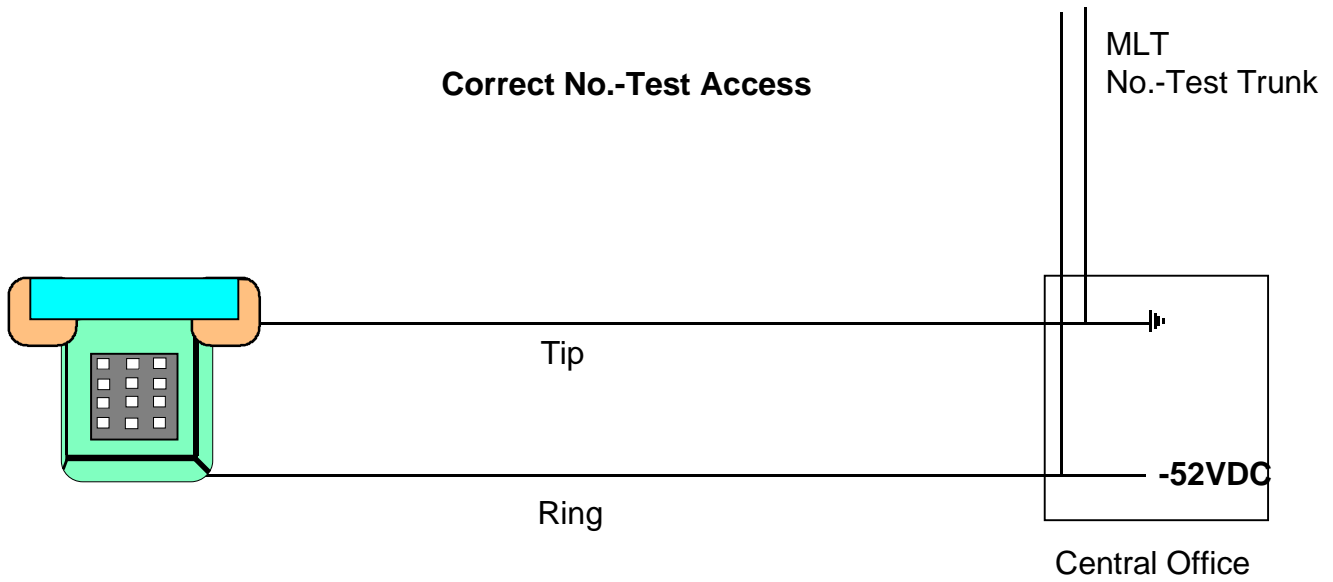
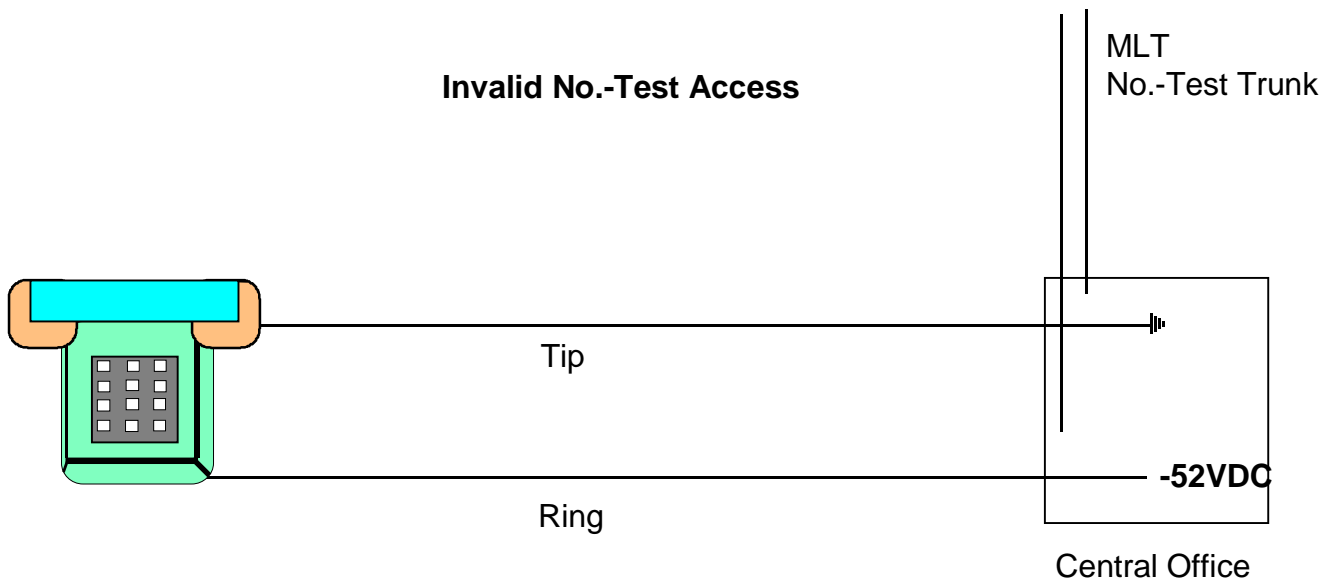
## VER 34 -- POSSIBLY INVALID ACCESS

This VER code indicates that MLT could have made an improper access to the line. MLT identifies this condition because it "sees" a VERY unusual situation where the line tests OPEN IN and OPEN LINE CKT.

OPEN IN is identified because MLT cannot see the customer's telephone set. At the same time, MLT cannot see the line circuit. An incorrect connection of the MLT No.-Test Trunk in the Central Office is almost always the cause of this situation.

The invalid access would not allow MLT to see the telephone nor the line circuit.

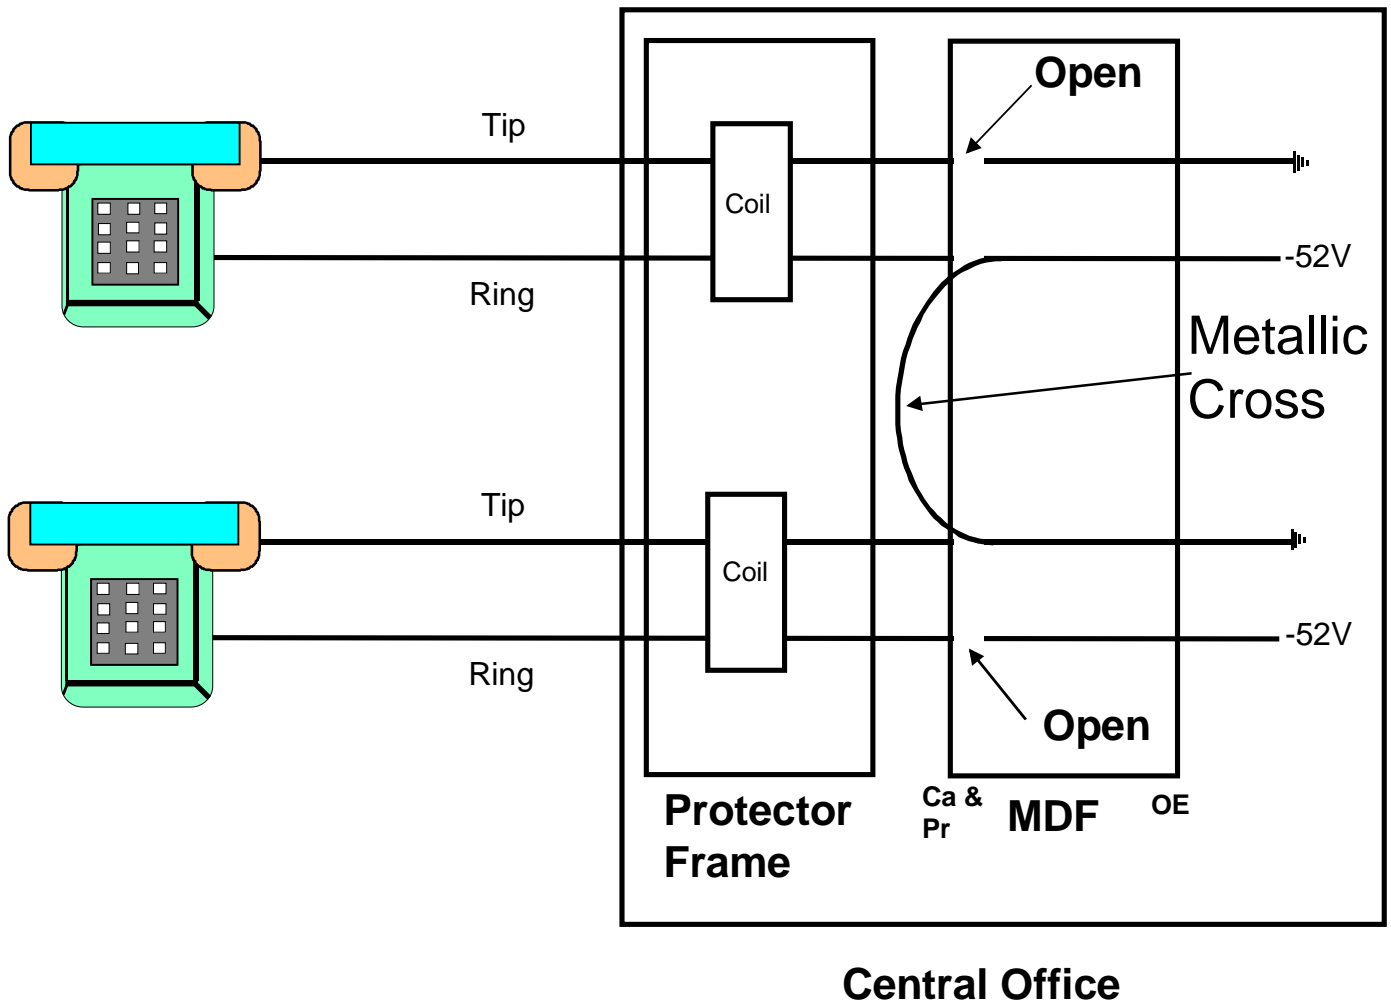
## VER 35 -- OPEN IN AND CROSS

MLT has detected an open and has determined that the open is in or very close to the central office. In addition, MLT has detected an MLT DC SIGNATURE that matches the requirements for a cross to working pair.

The combination of the ground and battery causes a cross type signature.

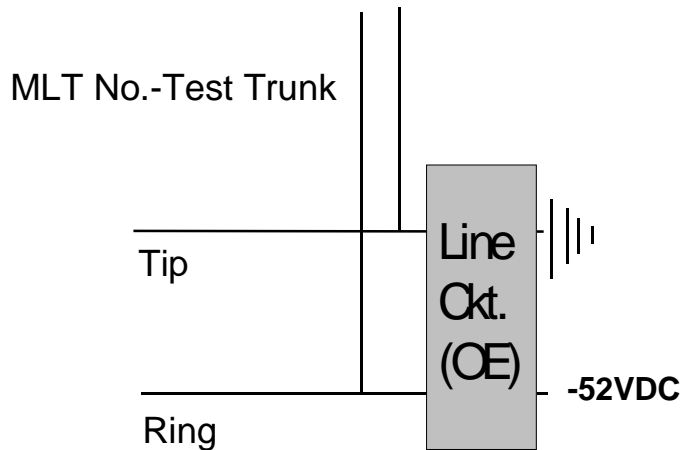
### Line Circuit OK

Note the diagrams on the facing page. The top graphic represents a correctly wired and functioning Line Circuit. The bottom graphic shows an example of a Line Circuit that could cause this test result.

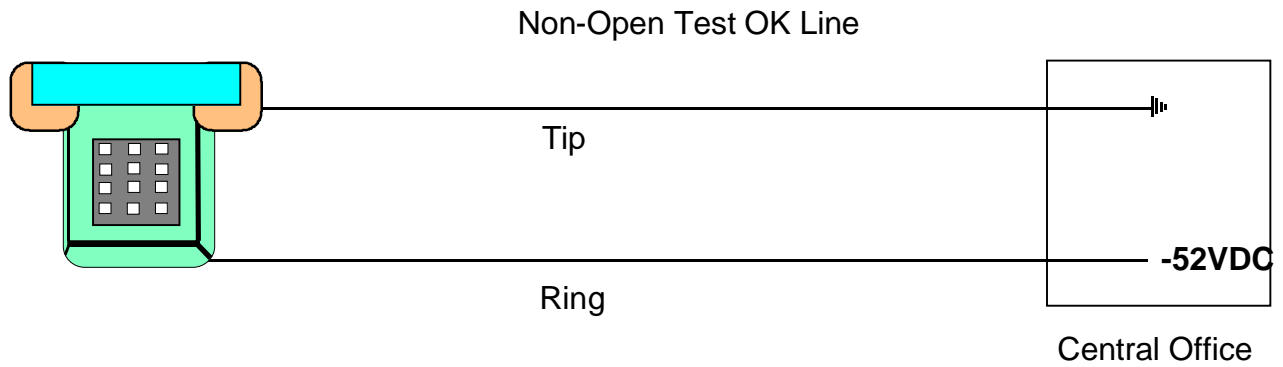
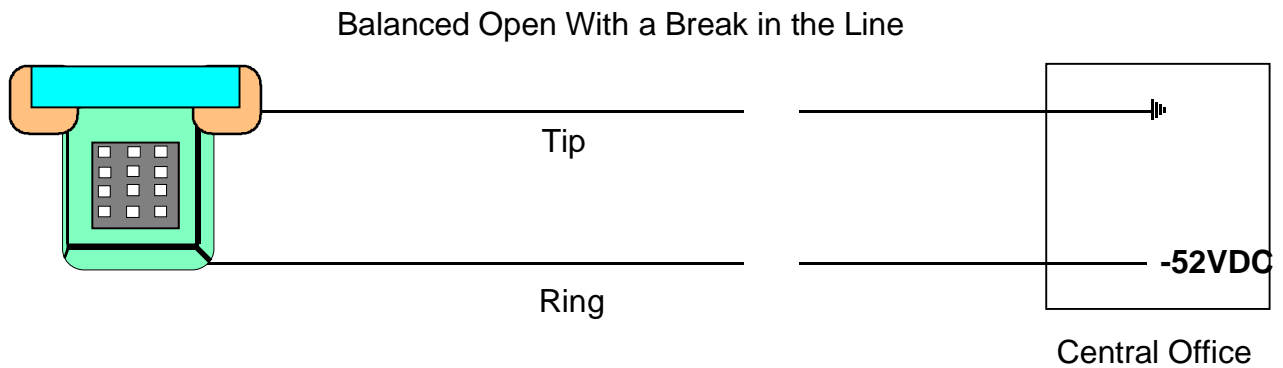
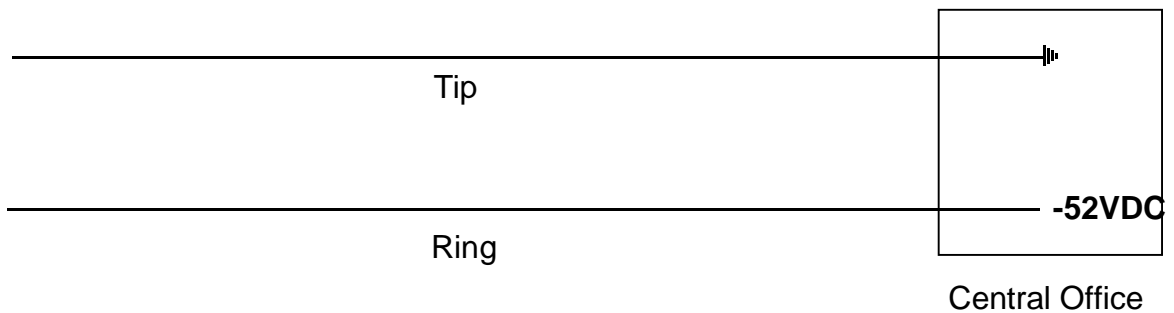
Balanced Open Due to Absence of a Telephone Set and a Network Interface

**VER 41 -- OPEN OUT BALANCED**

MLT has detected an open on the line and has determined that the open is outside the central office. MLT detects an open by not being able to see the capacitance of a ringer or network interface wired tip to ring. An open is simply a physical break in the telephone line. In a balanced open MLT estimates that the length of both sides of the line are roughly the same length. The capacitive balance, which indicates the difference in capacitance between both sides of the line, is 99% or greater. The higher the balance, the more closely the lengths of each side match each other. MLT also provides an estimate of the distance of the open from the central office.

Balanced opens are usually open on both sides in the same place. There is no direct way to tell whether the open is close to the station or back in the cable. The distance of the open from the central office, however, can be helpful in pinpointing the open more specifically.

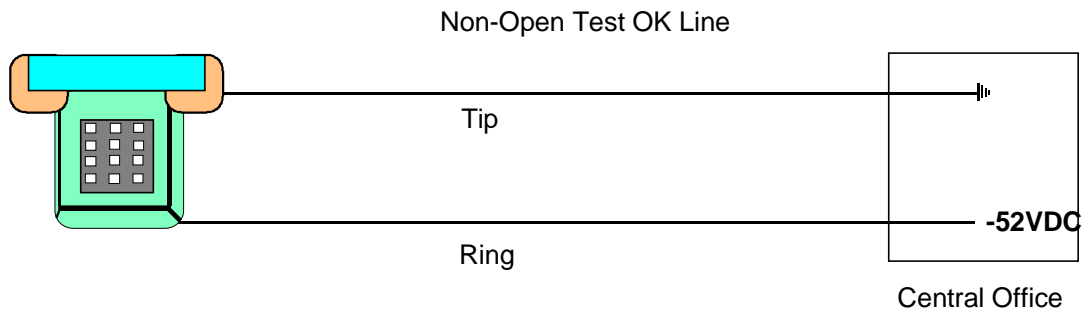
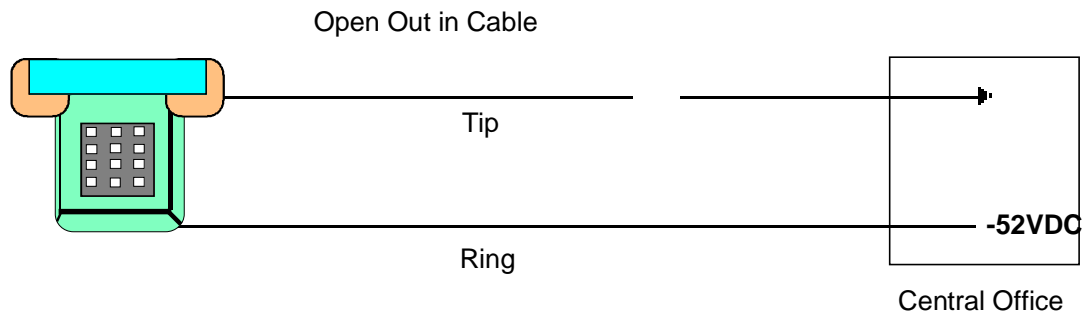
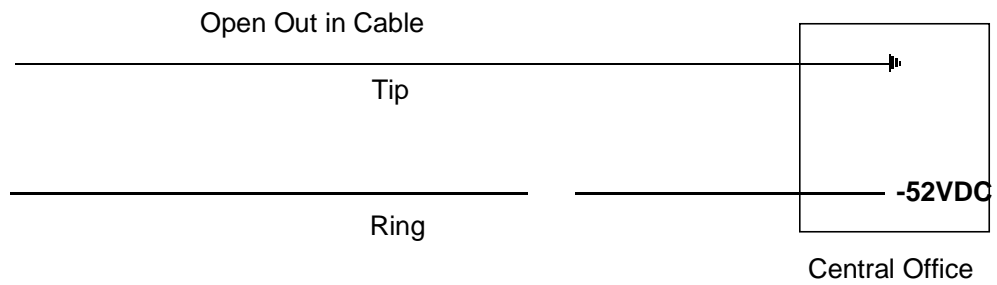
## VER 42 -- OPEN OUT IN CABLE

**VER 42 -- OPEN OUT IN CABLE**

MLT has detected an unbalanced open on the line. When an open is unbalanced, one side of the line is significantly shorter than the other one and that is usually because only one side is really open. Generally, it is assumed the shorter one is open. MLT uses capacitive balance to decide if the open is balanced or not. If the CAP BAL is less than 99%, it calls the condition an unbalanced open. MLT has the ability to measure the capacitance on each wire and convert that capacitance to an equivalent footage amount.

As mentioned above, the estimates of the open's distance from both the CO and the station are displayed to the user. These should be helpful in coordinating a repair person's search for the trouble.
