# **MLT Ver Codes**

# MLT VER Codes

The purpose of this module is to provide more detail on how to use a combination of VER code, Summary Message, and Test results to make the best decision for the customer and the company. It also provides a Job Aid to help the MLT user access the best possible information about MLT in a VER code listing.

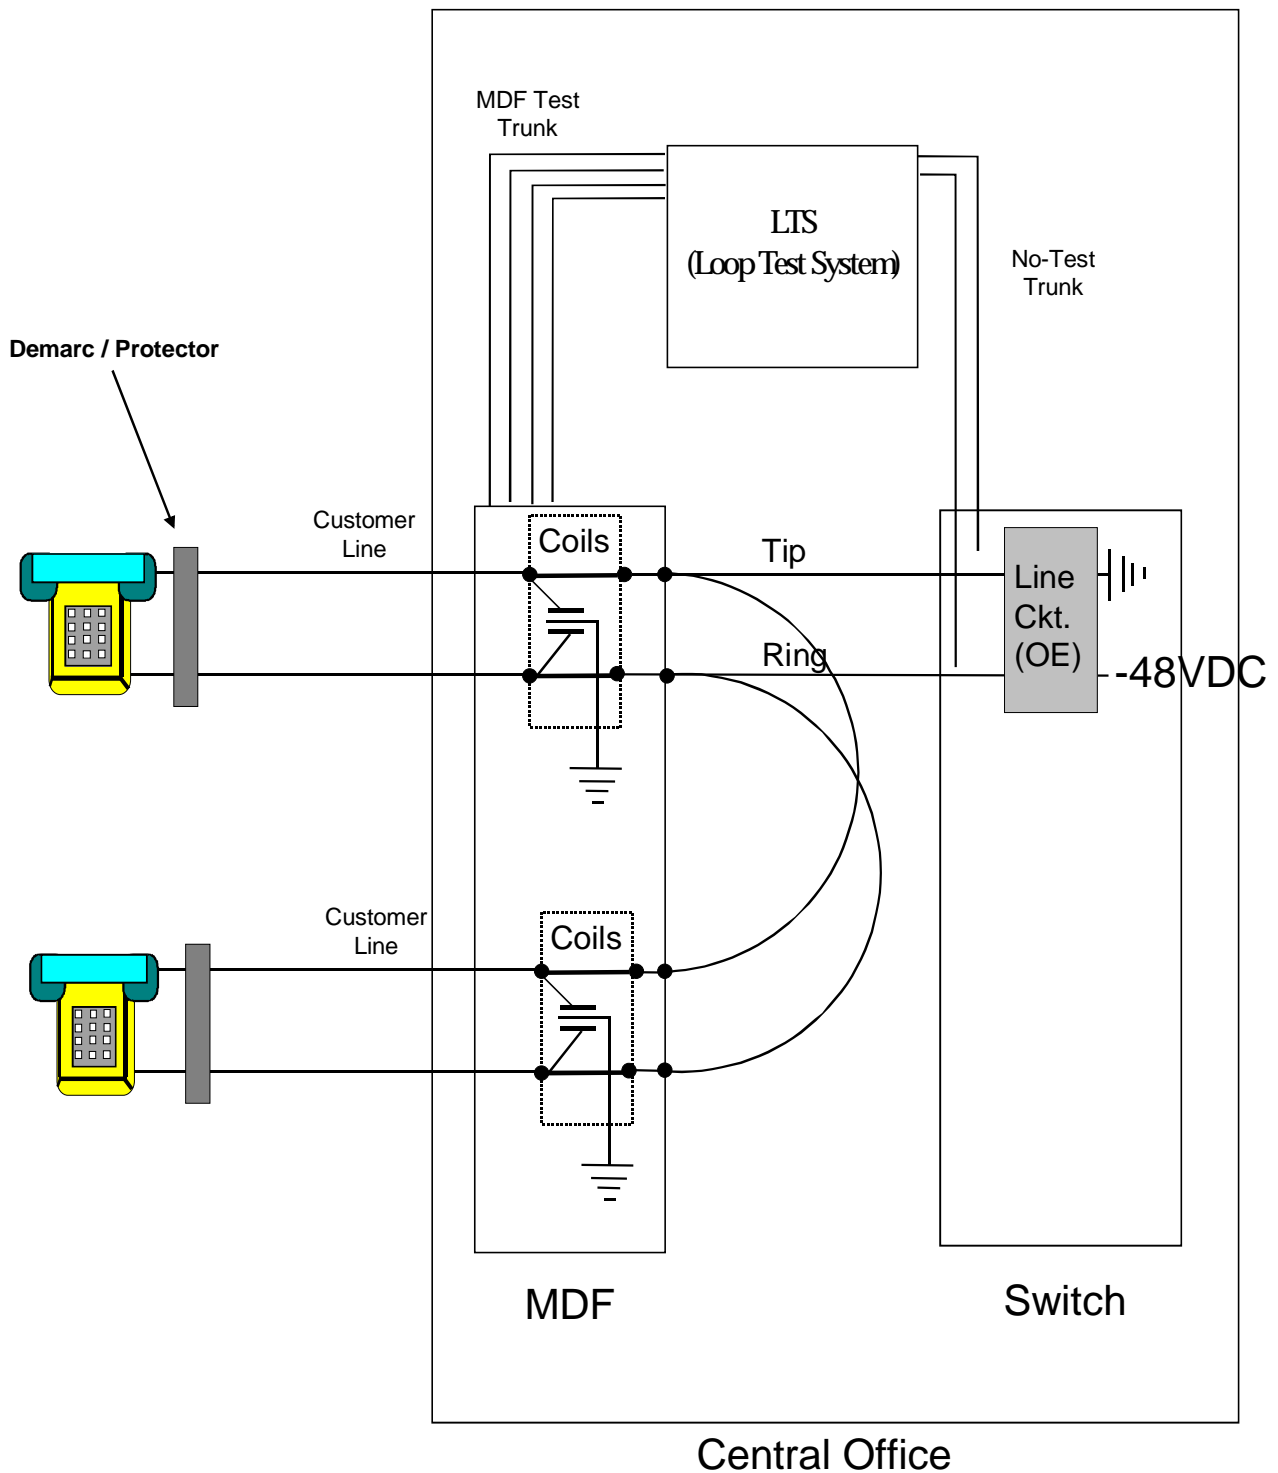
## VER 44 -- OPEN OUT 2 - PARTY OR BRIDGE LIFTERS

**VER 44 -- OPEN OUT 2 - PARTY OR BRIDGE LIFTERS**

**Southwestern Bell no longer has 2 party lines so this result will mean the line has a Bridge Lifter in its records.**

Because of the Bridge Lifters, no open measurements are available for this condition. The capacitive balance and the distances calculated from the capacitances can be distorted by the Bridge Lifters. This distortion can produce wrong or misleading values. In order to avoid this, no measurements are displayed. The open is outside of the CO, but MLT cannot decide which pair the trouble is on. It also cannot decide if the open is balanced or not.

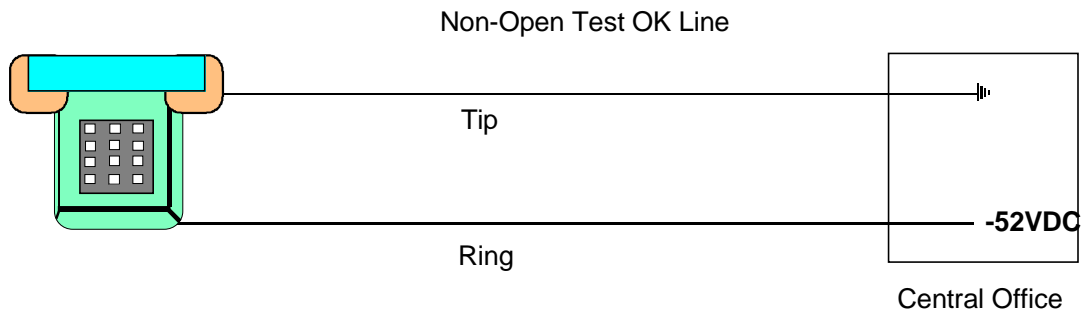
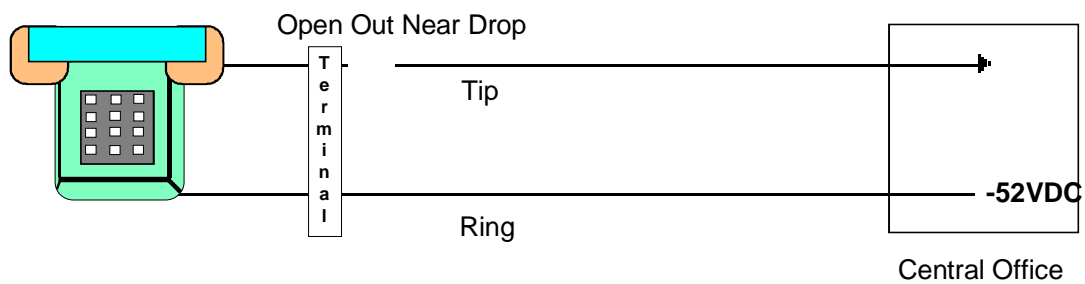
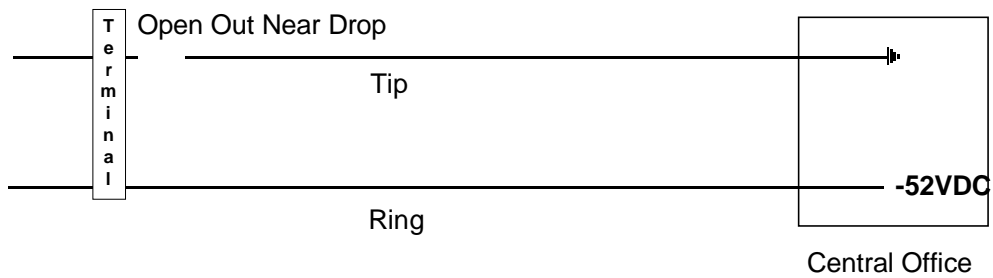
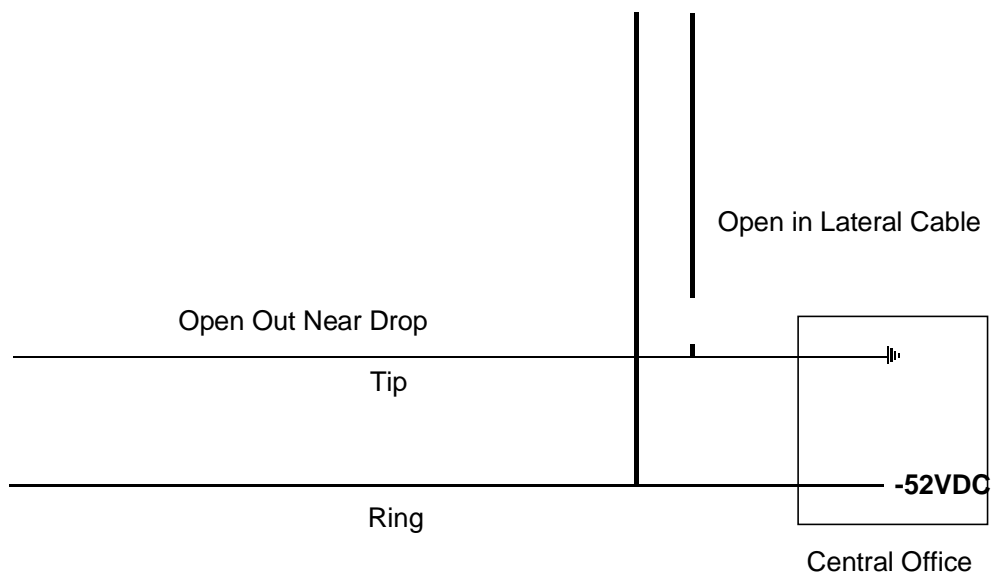
**VER 45 -- OPEN OUT NEAR DROP**

MLT has detected an unbalanced open on the line. When an open is unbalanced, one side of the line is significantly shorter than the other one and that is usually because only one side is really open. It is assumed that the shorter one is the open one. MLT uses capacitive balance to decide if the open is balanced or not. If the CAP BAL is less than 99%, it calls the condition an unbalanced open.

MLT will call the result OPEN OUT NEAR DROP if one of the following two situations is found:

The estimates of the open's distance from the CO and the STATION are displayed. These should be helpful in coordinating a repair person's search for the trouble.

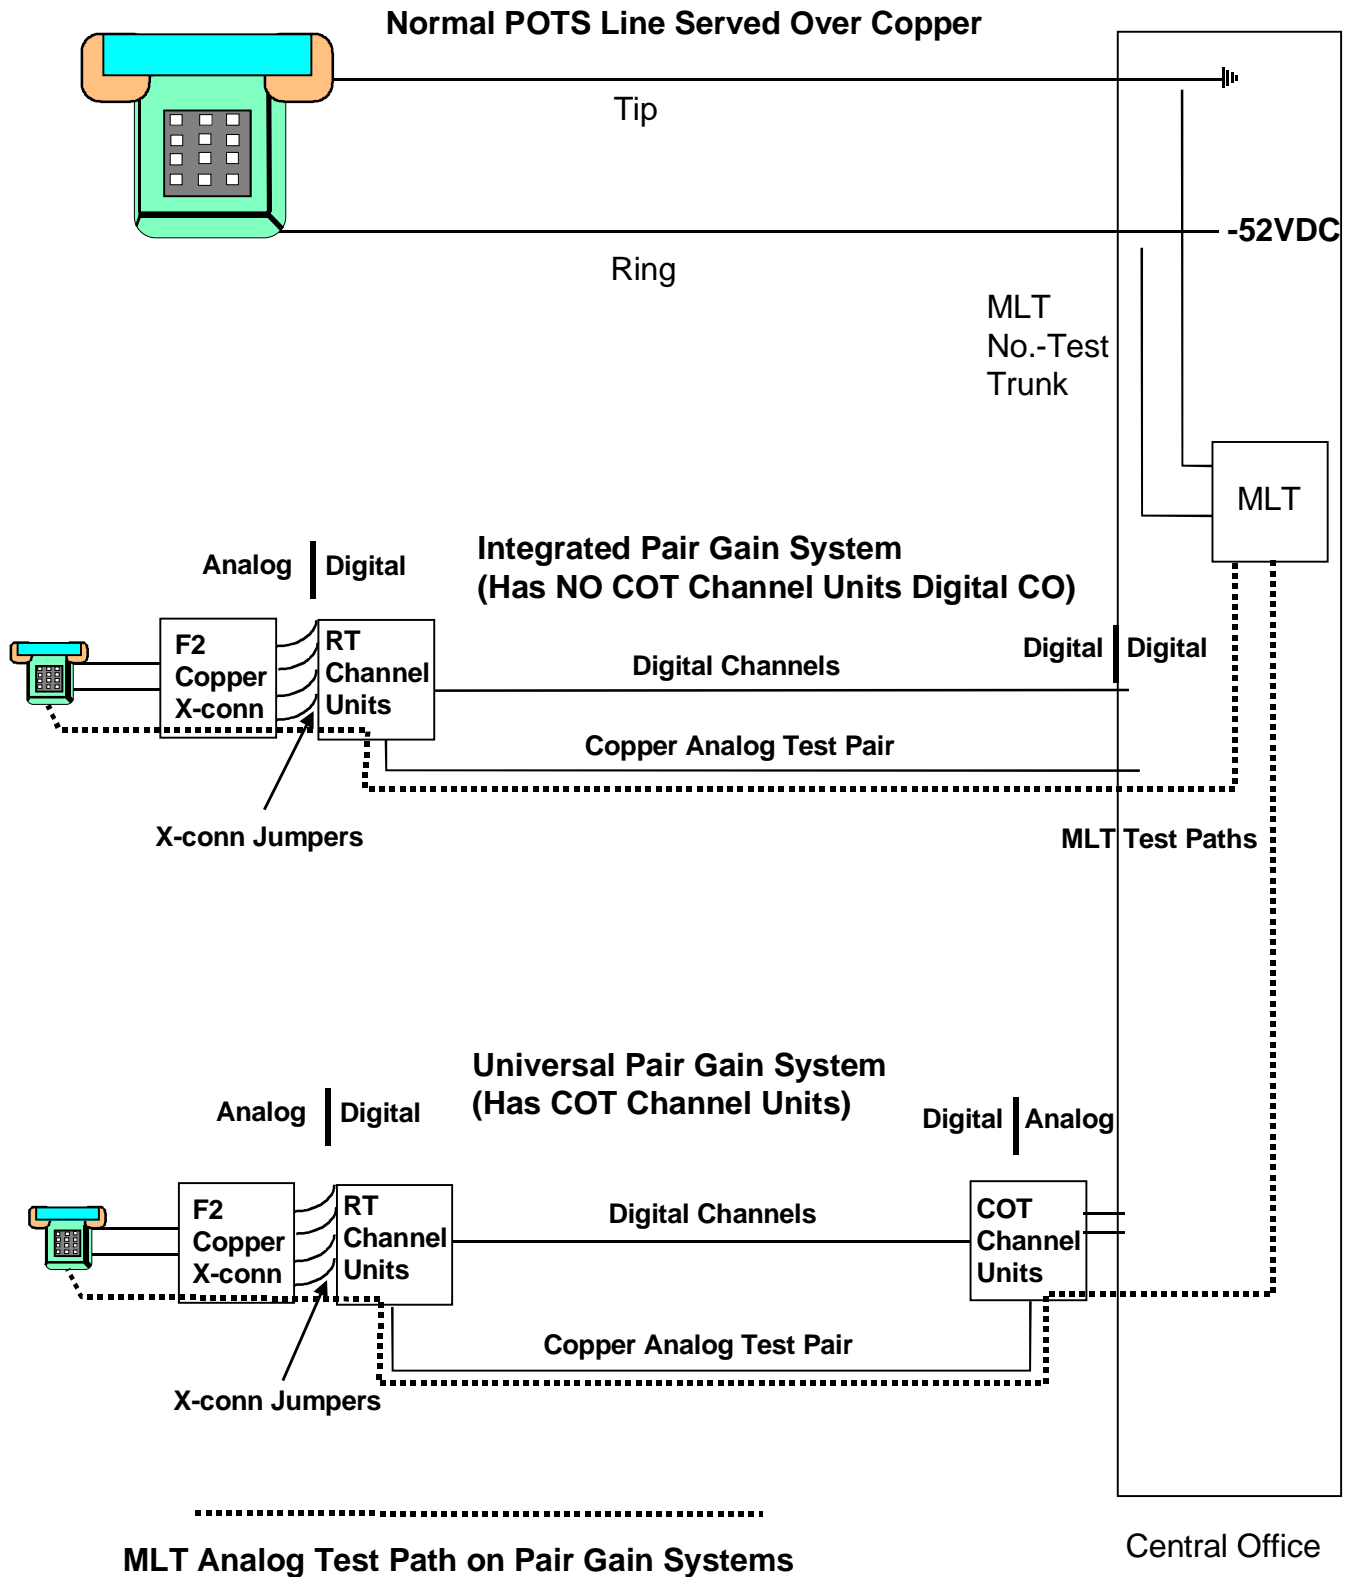
## VER 05 -- CHANNEL STATUS NOT IDENTIFIED

**VER 05 -- CHANNEL STATUS NOT IDENTIFIED**

This VER code is applicable to all switches and applies to both integrated and universal DLC (Digital Loop Carrier) loops. This VER code indicates that all metallic test passed, but the channel test either was not made or did not complete in time to be returned or the results did not match the acceptable signatures. It does not mean that the channel is bad. It is just unknown. In the case of an integrated DLC (IDLC) in 5ESS switches, it may be an indication of a shortage of TTF (Transmission Test Facility) responders. The TTF performs the IDLC (Integrated Digital Loop Carrier) channel tests.

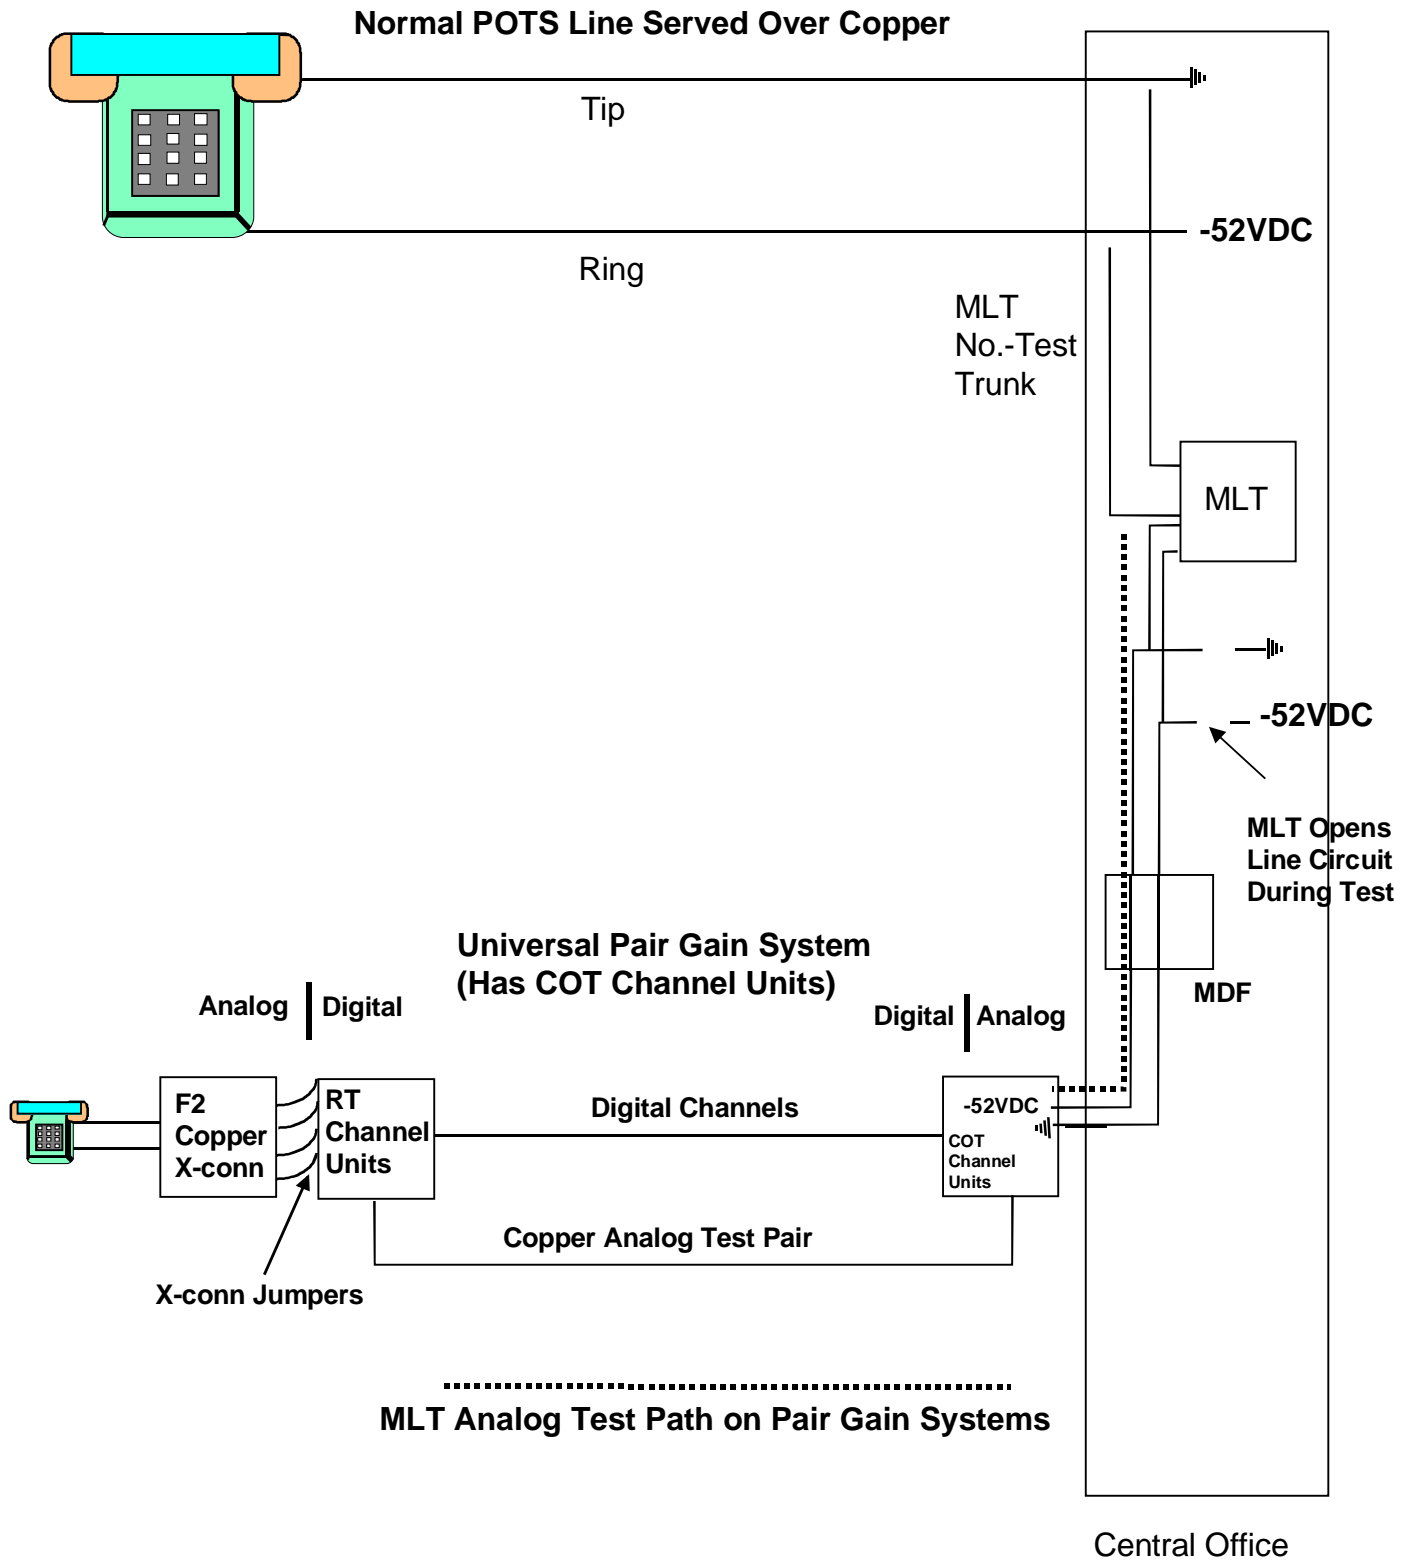
## VER 51 -- CO BATTERY ON PAIR GAIN SYSTEM

A busy (with no speech) condition is detected on a SLC<sup>®</sup> 96 line with a COT Channel Unit. Testing determines that there is voltage on the line not due to a line in use or a permanent signal condition. MLT assumes that there is CO battery on the pair gain access system. Testing is stopped and no metallic access is attempted.

This condition may be at the pair gain system in the central office. It should be routed according to local pair gain procedures.

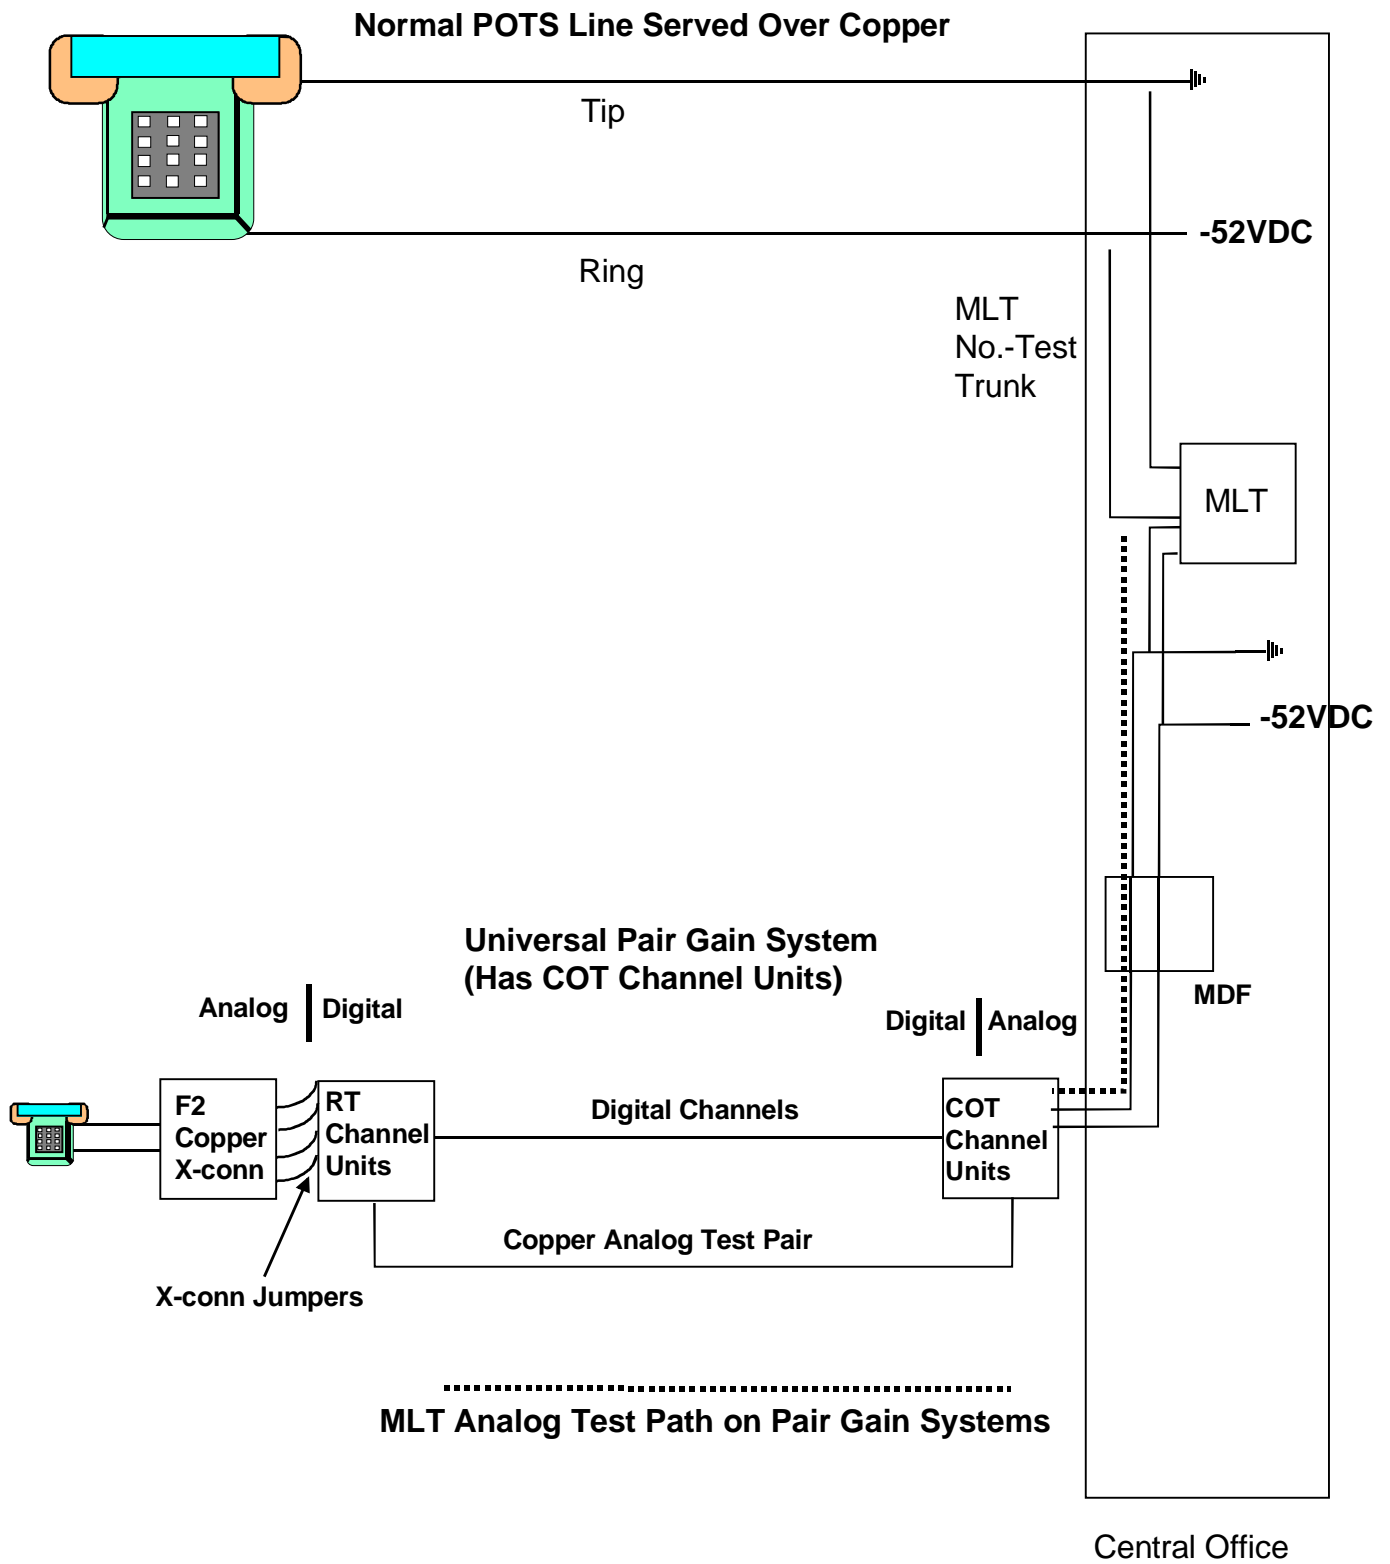
## VER 52 -- INVALID PAIR GAIN C.O. SIGNATURE

**VER 52 -- INVALID PAIR GAIN C.O. SIGNATURE**

Prior to metallic access MLT attempts to identify the C.O. signature for the SLC 96 equipment. If the C.O. signature that is identified is not one that is expected, MLT will call the signature invalid and this summary will be set. Testing is stopped and no metallic access is attempted.

This condition could exist due to a record error. The SLC 96 may not be on the line as the records indicate or the SLC-96 service may not be the one indicated in the records. Determine whether or not the records are correct. If they are not, follow local procedures for correcting them. If they are correct and there is an invalid C.O. signature, the problem is most likely in the central office.

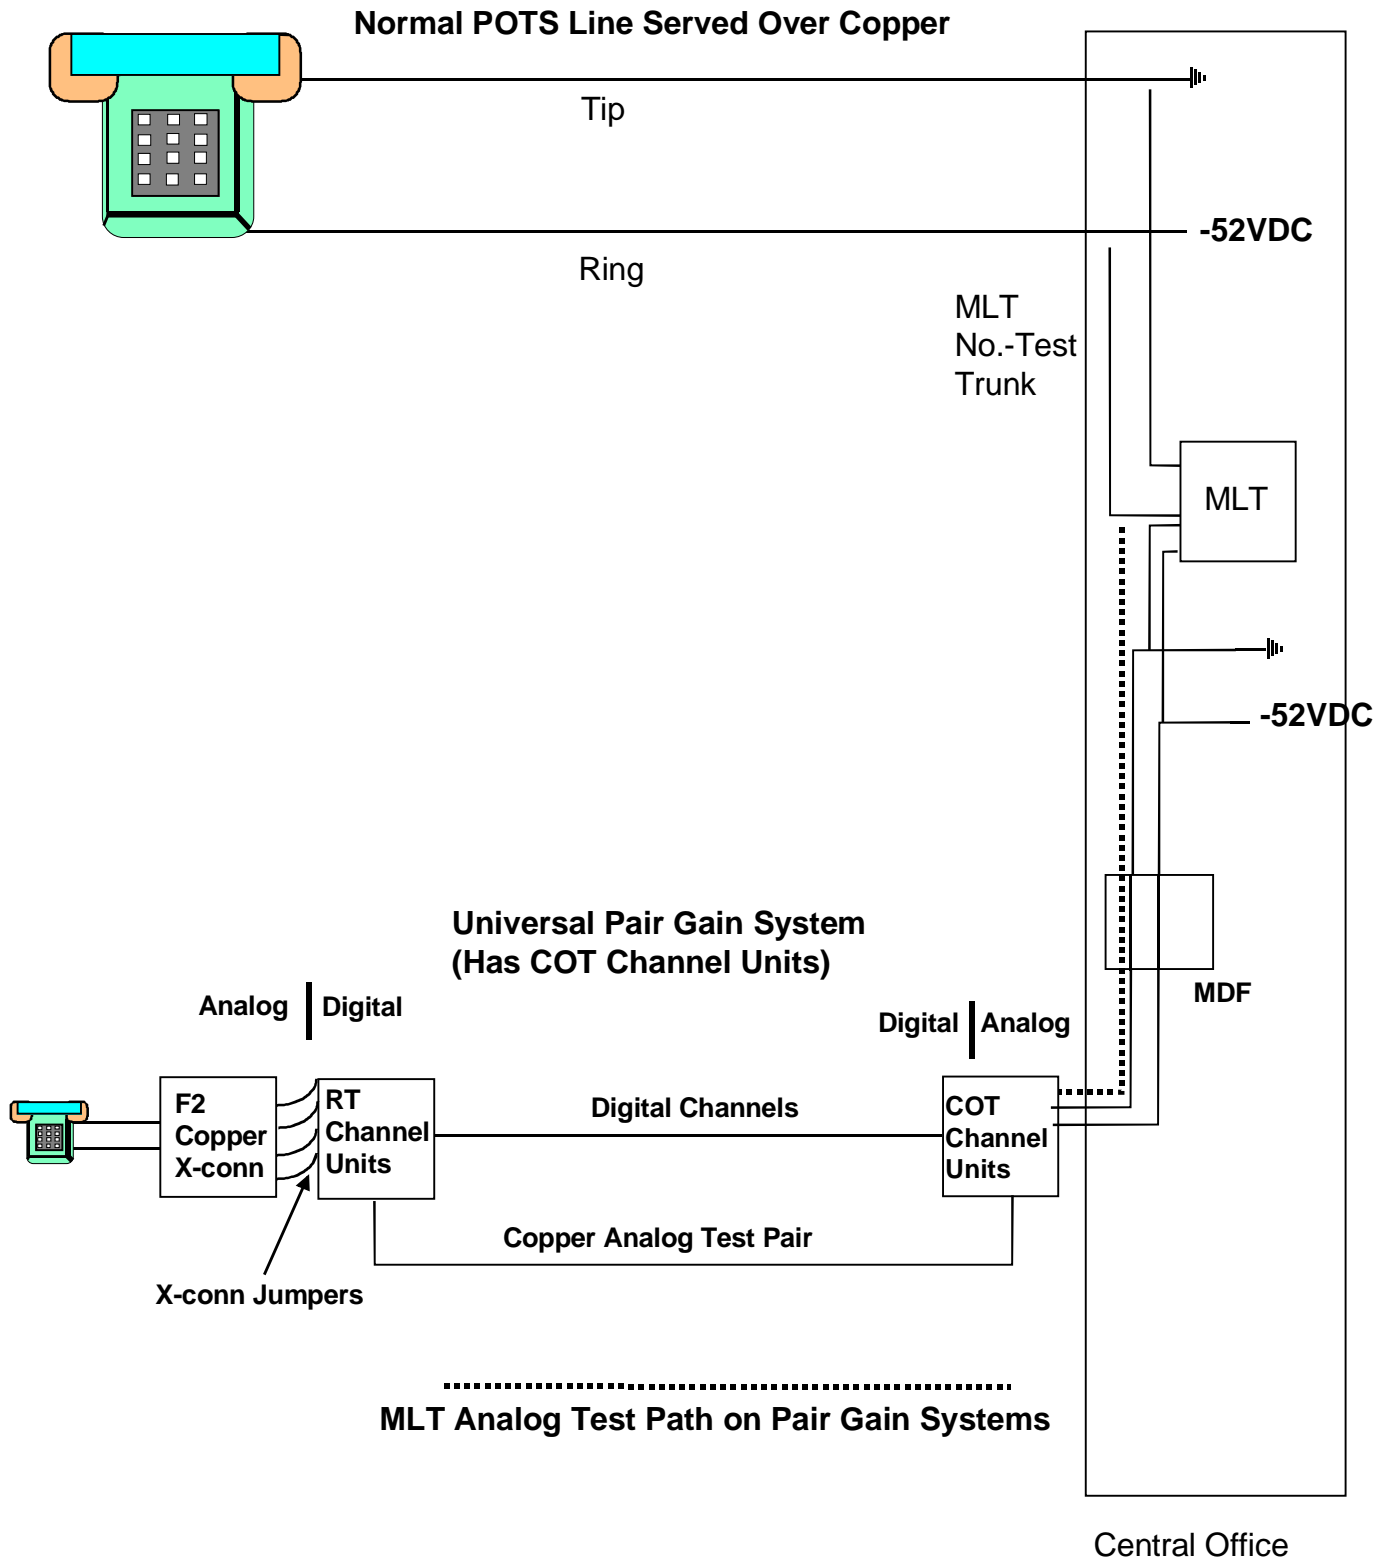
## VER 53 -- PAIR GAIN SYSTEM BUSY

## **VER 53 -- PAIR GAIN SYSTEM BUSY**

MLT cannot make metallic access on the pair gain system because someone else is using the metallic access path to test the line. Testing is stopped and no metallic access is attempted. When a VER code 53 is generated, MLT will automatically drop access to the line.

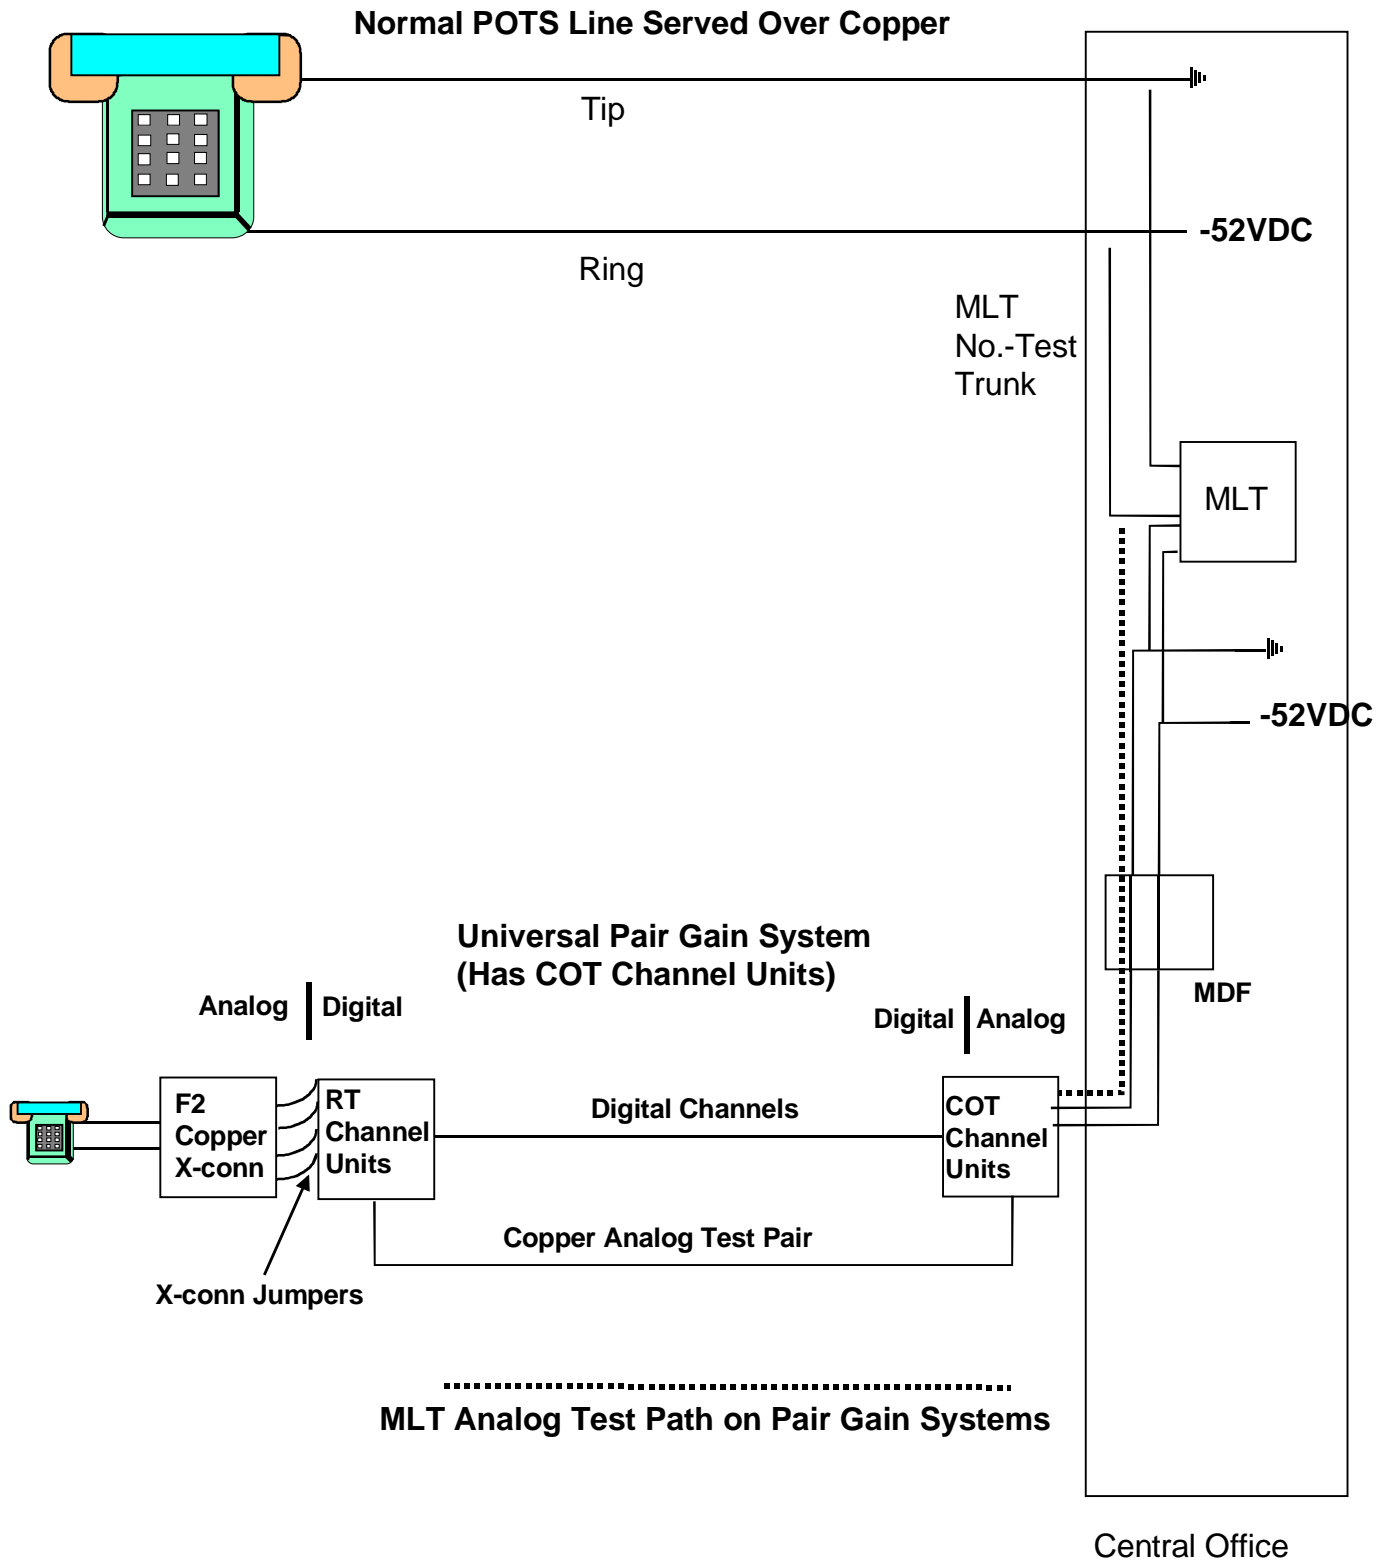
## VER 54 -- PAIR GAIN SYSTEM FAILURE

## **VER 54 -- PAIR GAIN SYSTEM FAILURE**

MLT cannot make metallic access on the pair gain system because:

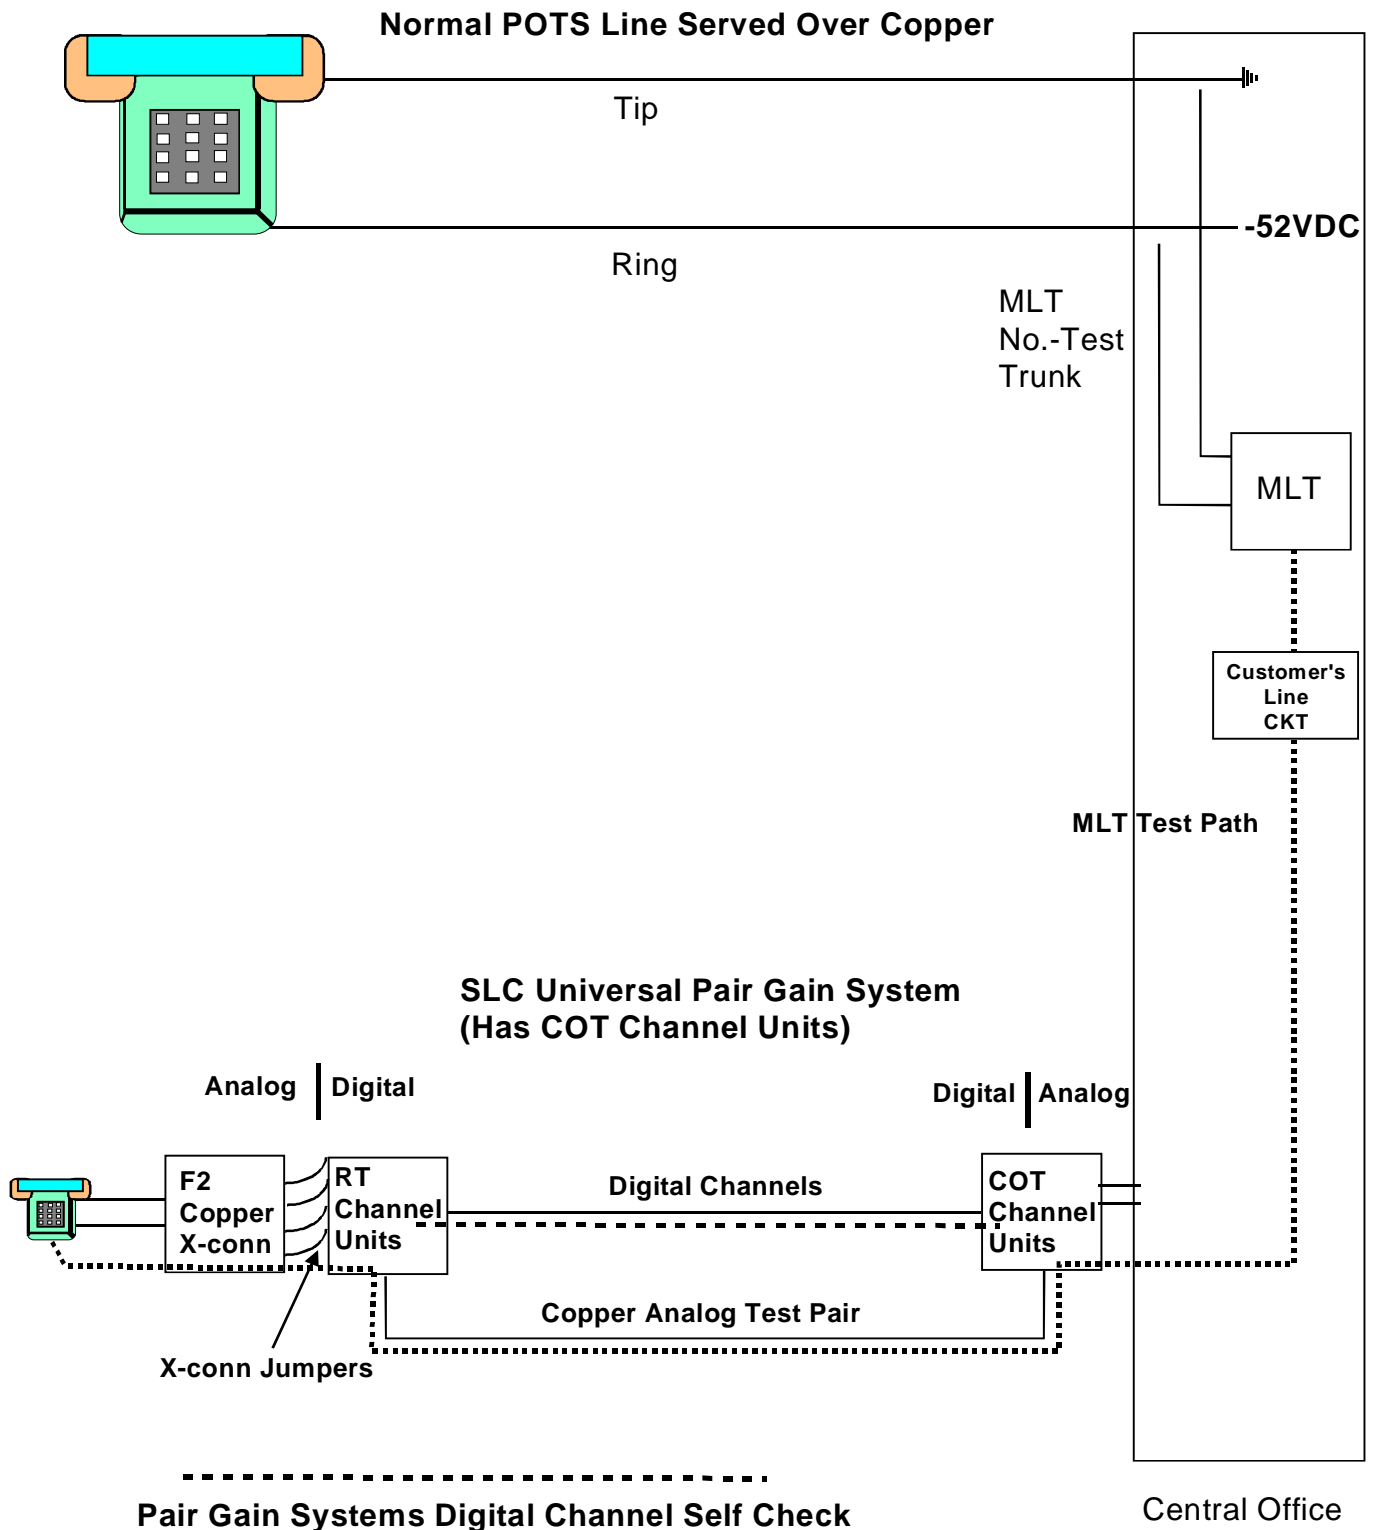
**VER 56 - BAD COT CHANNEL UNIT**

This VER code is returned if the Digital Loop Carrier (DLC) self check reveals a bad channel at the COT (Central Office Terminal). This result is present only on SLC lines with the XTC (Extended Test Controller).

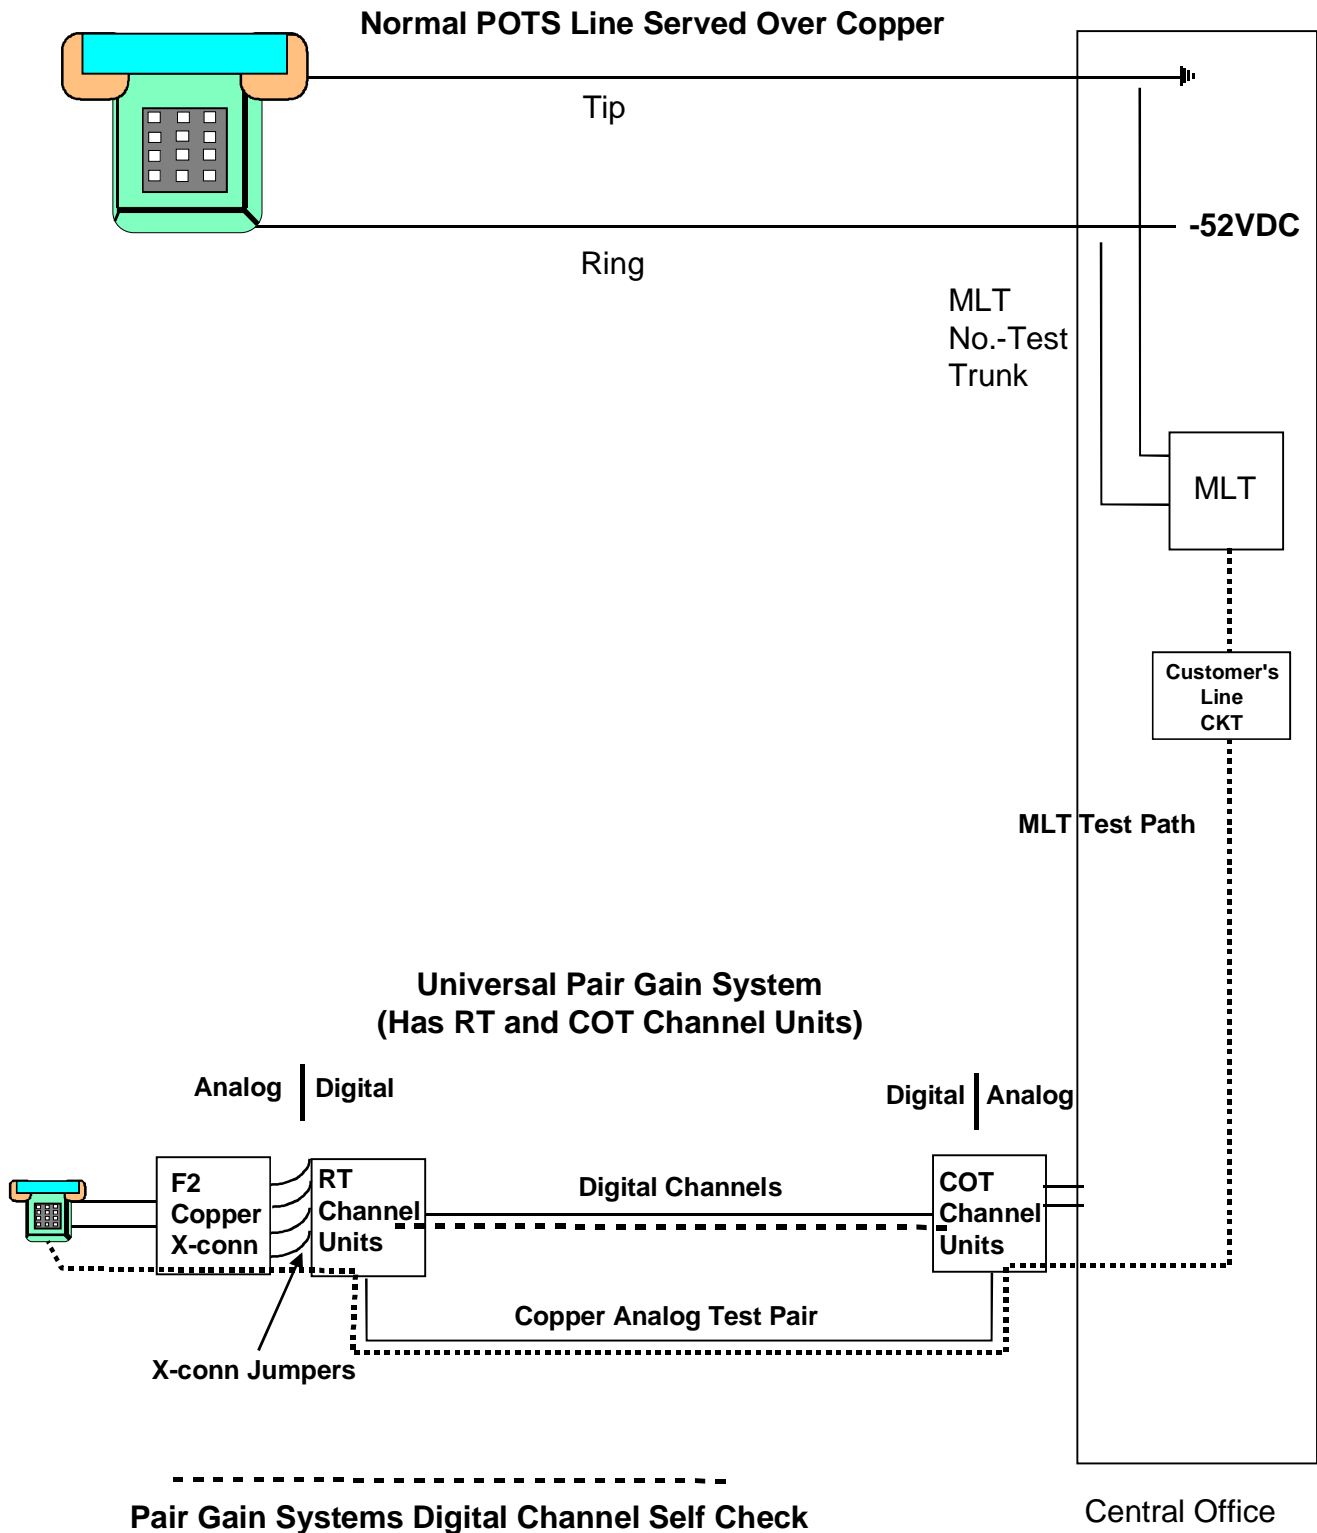
## VER 57 - RT CHANNEL UNIT BAD

## MLT Analog Test Path on Pair Gain Systems

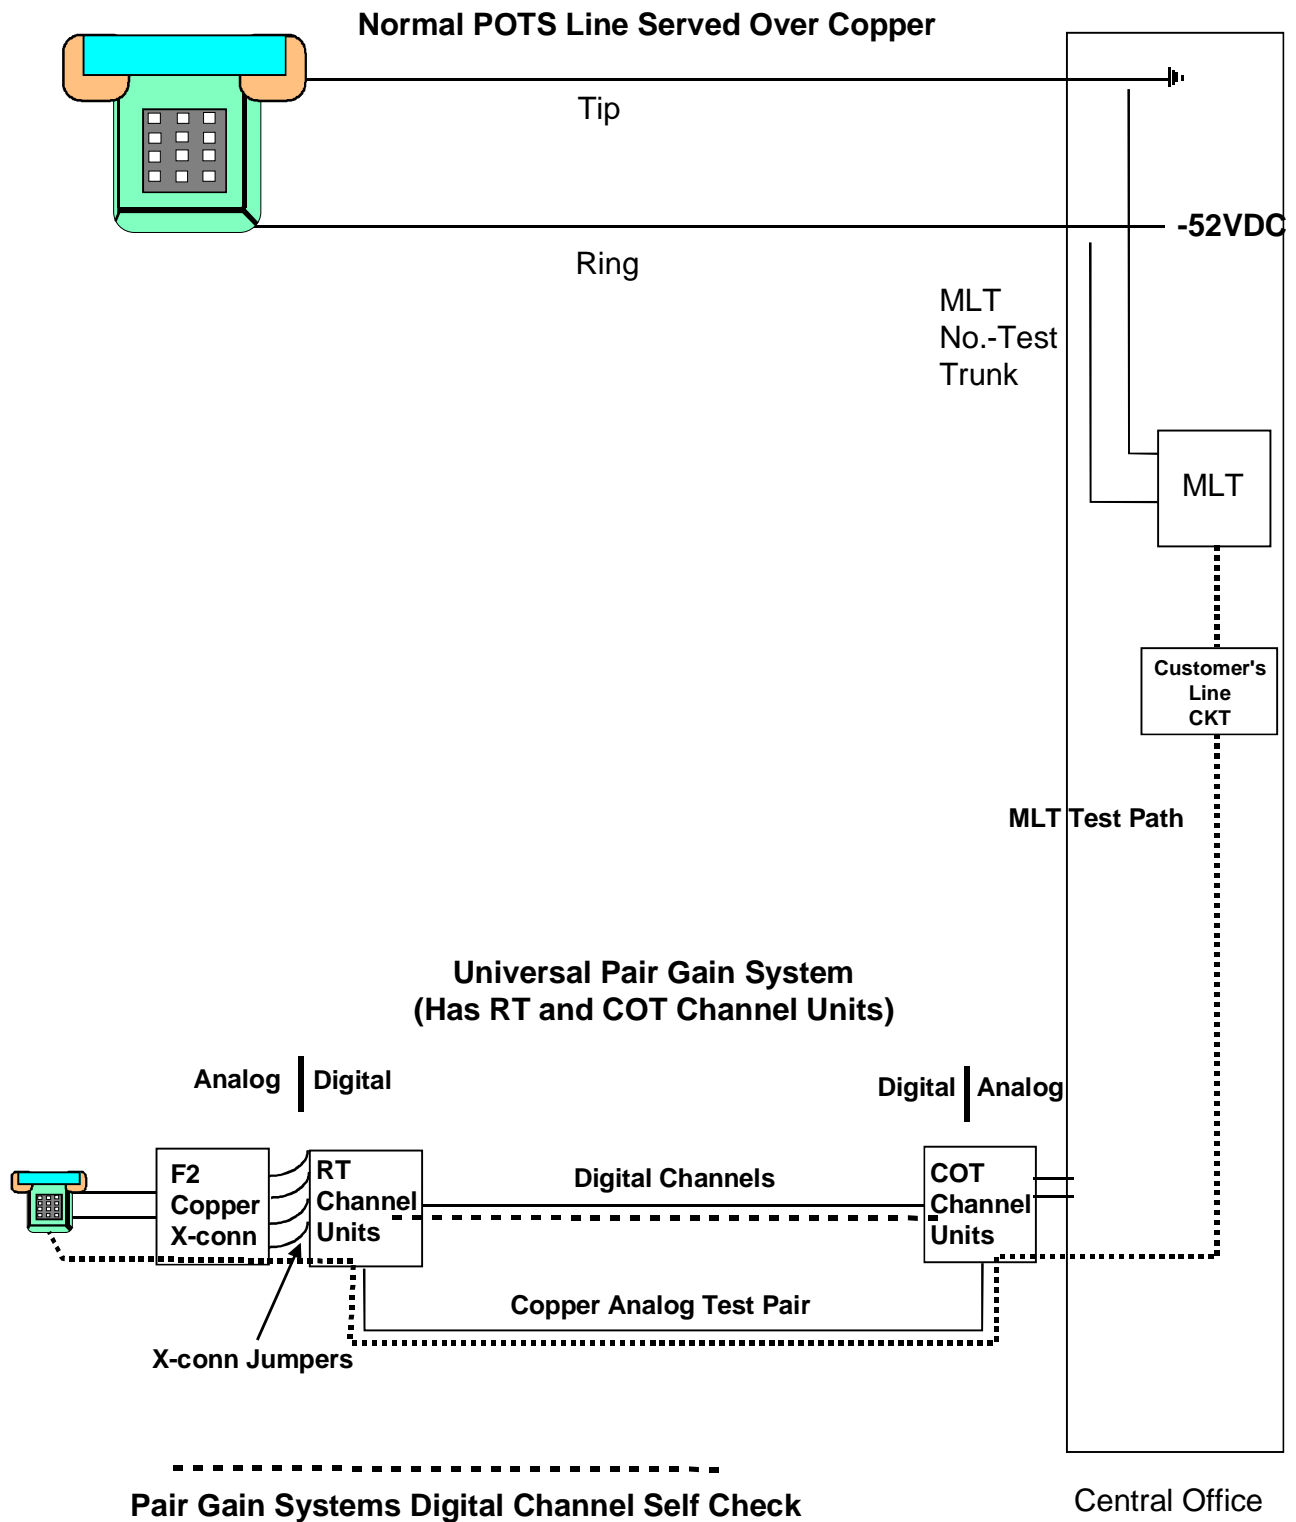
## VER 58 - BAD COT AND RT CHANNEL UNITS

## MLT Analog Test Path on Pair Gain Systems

**VER 58 - BAD COT AND RT CHANNEL UNITS**

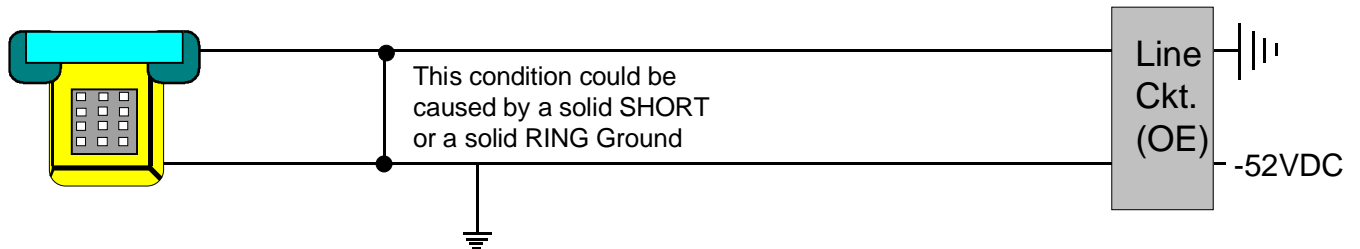
## VER 6 -- BUSY-SPEECH

## **VER 6 -- BUSY-SPEECH**

MLT found a LINE IN USE condition and then SPEECH. Testing stopped at this point. To MLT BUSY SPEECH means MLT sees a LINE IN USE condition along with changes occurring on the line. Changes (sounds) can be customers actually talking, customers on hold with music or other sounds, recorded announcements, the Central Office sounder or howler, or even noise.

MLT's program looks for LINE IN USE or BUSY conditions when it is accessing the line in order to not interfere with customer service. MLT is not allowed to kill the CO battery and ground when a LINE IN USE or BUSY condition is found. MLT can never get a valid test result if it is not able to kill CO battery and ground. LINE IN USE is identified by MLT as current flowing on the line at the time of access. Remember current should not flow on a line when the phone is on hook. Sometimes MLT is misled because current can also flow when there is a fault on the line such as a short, ring ground, ROH, trunk hung in the CO, or premise equipment hung.

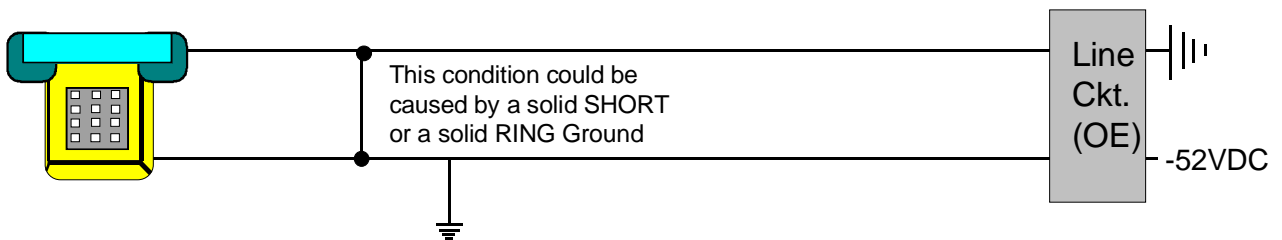
## VER 61 -- LINE IN USE

**VER 61 -- LINE IN USE**

MLT has determined that the line was being used at the time of testing, but no speech was detected. This result can be caused by a completed telephone circuit and the people are not talking or on hold.

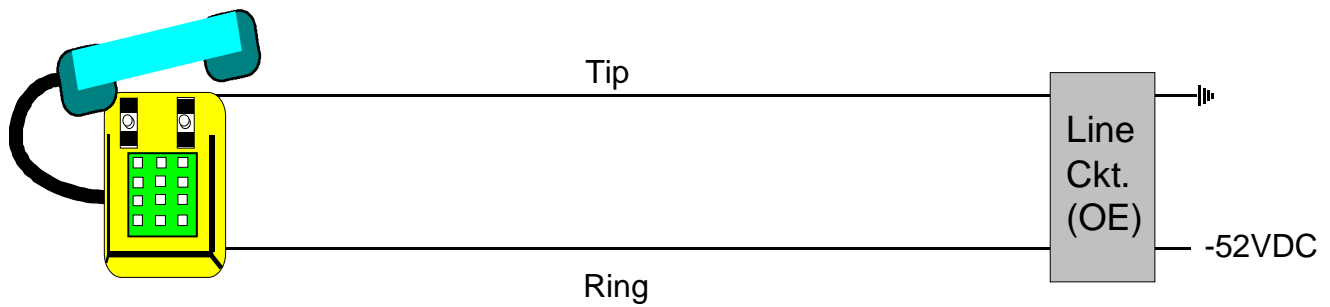
## **VER LU -- LINE IN USE**

This VER code will appear when the subscriber is calling on the line to be tested via ECRS. It is caused by the CSR entering a "Y" in the Line in Use? Field on the ECRS Maintenance Work Item Entry screen.
