# **MLT Ver Codes**

# MLT VER Codes

The purpose of this module is to provide more detail on how to use a combination of VER code, Summary Message, and Test results to make the best decision for the customer and the company. It also provides a Job Aid to help the MLT user access the best possible information about MLT in a VER code listing.

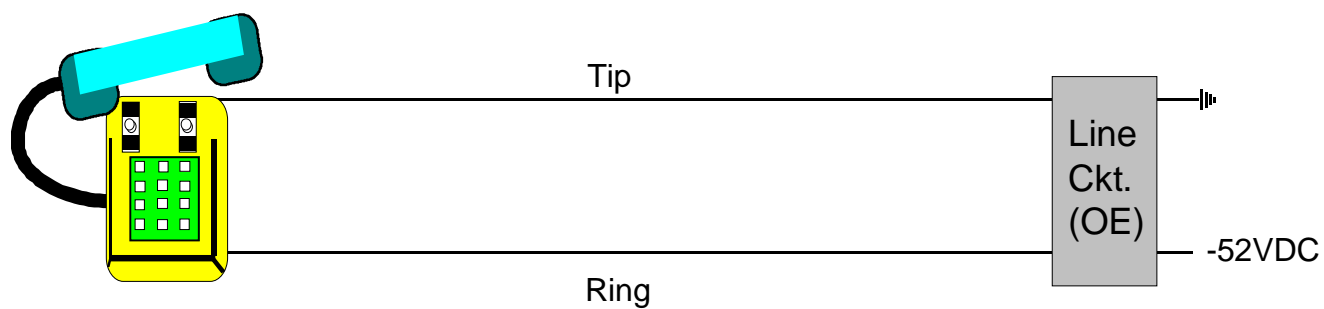
**VER 71 -- ROH (Receiver Off Hook)**

## VER 71 -- ROH (Receiver Off Hook)

When MLT tests a line with a short value between .1 and 3.4 KOHMS, it automatically performs the ROH test. If MLT finds an ROH condition it stops testing and presents the results below. The ROH test performs reliable tests that can actually tell when there is physically a Receiver Off Hook.

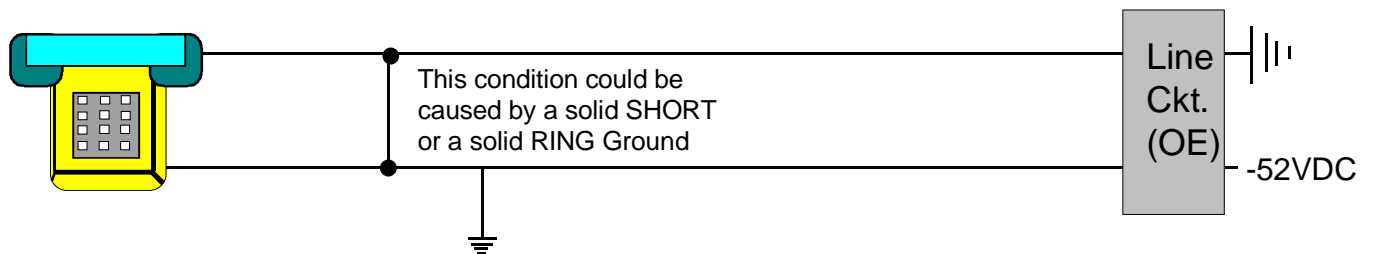
## VER 74 -- PERMANENT SIGNAL

Below are the values MLT finds (along with record conditions described on the facing page) to set VER 74.

MLT: KOHMS	DC SIGNATURE VOLTS	
.15 to 3.4		T-R
>150	<3	T-G
>150	<3	R-G

In ESS Central Offices MLT decides that the line is busy, but there is no speech. Next, it checks for PERMANENT SIGNAL and finds it. The PERMANENT SIGNAL is on the line because of a resistive fault or an ROH condition. MLT cannot detect ROH because the line is not ROH testable.

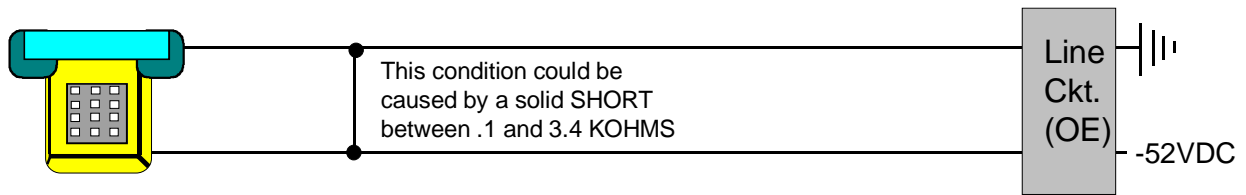
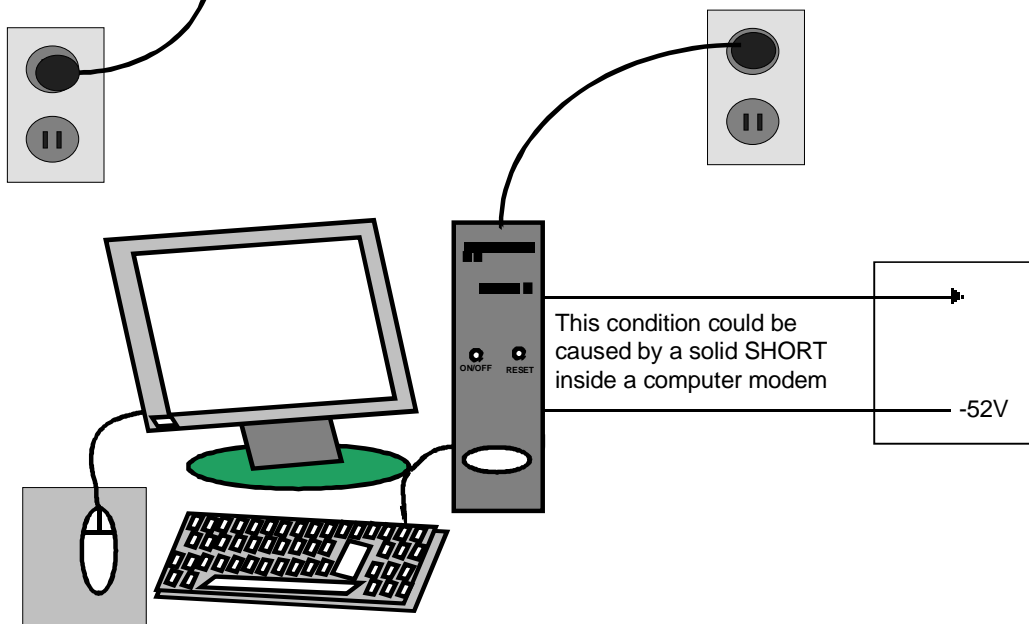
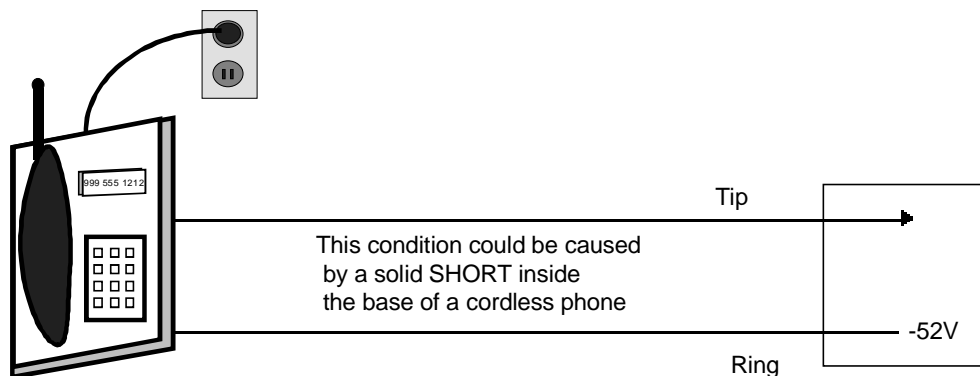
## VER 75 -- SHORT - PROBABLY ROH

**VER 75 -- SHORT - PROBABLY ROH**

This VER code is set, if the MLT DC resistance value T-R is between .1 KOHMS and 3.4 KOHMS, and MLT does not find an ROH condition. If this test doesn't verify an ROH condition, it is not possible for MLT to determine directly whether the trouble is the result of an equipment problem or a short fault. The MLT user should ask the customer to unplug their equipment inside the service location and any connection to AC power, or unplug the telephone line at the Network Interface. This problem is NOT an ROH.

This fault can be caused by telephone equipment that uses AC power to answer and/or hold access to a telephone circuit. It can also be caused by any short between .1 and 3.4 KOHMS and MLT does not find an ROH.

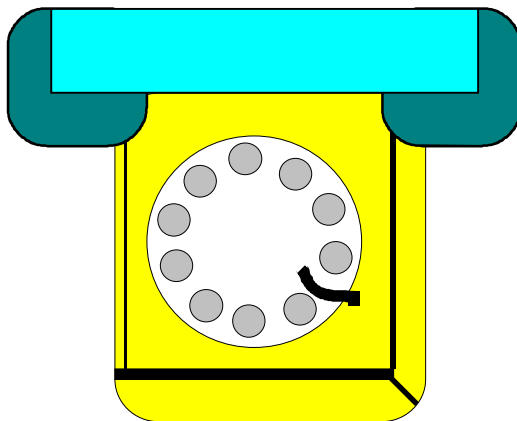
## VER 80 -- DIAL OK

The MLT rotary dial test (DIAL) was run and the results indicate that the dial was working properly. This means that the dial speed was correct (8 to 11 pulses per second), and the percent break was within acceptable range (57 to 64 percent).

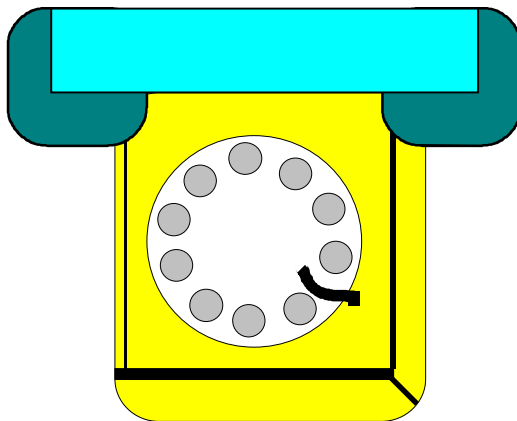
## VER 81 -- DIAL NOT OK

The MLT rotary dial (DIAL) test has been run and a problem with the dial has been detected. The problem could be with the dial speed (correct dial speed is 8 to 11 pulses per second), or the percent break (the correct range for the break is 57 to 64 percent). Remember, however, that the percent break may occasionally fall within this range and the summary message will still say DIAL NOT OK. This is because the break that is reported in the test results is an average for all 10 pulses. If even one fails, MLT will report that the dial was not OK, but the average break may still fall within the acceptable range.

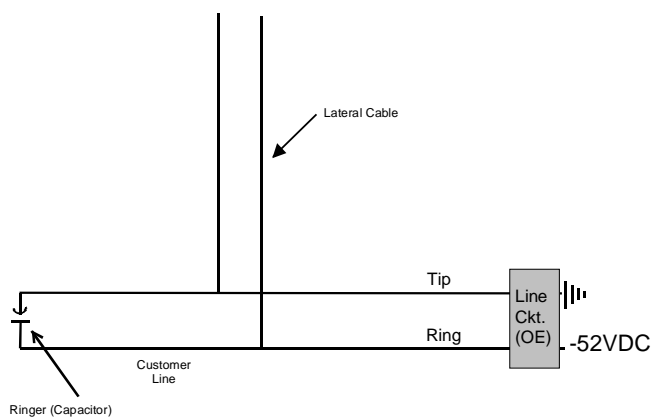
## Line OK

MLT detects no major faults on the line except POOR LONGITUDINAL BALANCE (below 40 DB), and POOR CAPACITIVE BALANCE (less than 95 percent). This condition could be caused by one of the following:

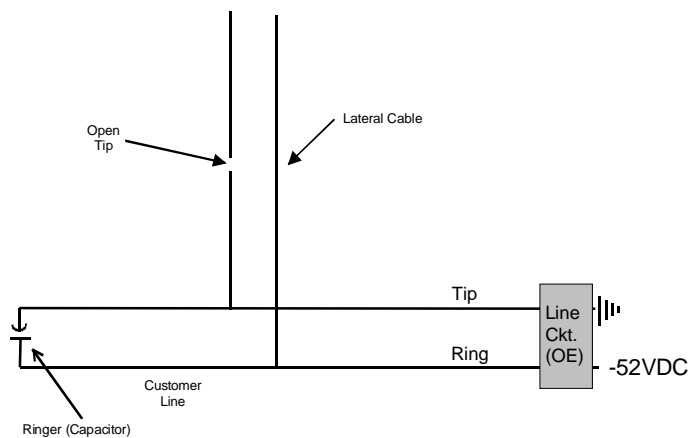
## Line Unbalanced - Lateral Cable Pair

- capacitance imbalance due to cable bridge tap
- capacitance imbalance due to cross to a non-working cable pair
- ringer or other termination improperly connected to ground

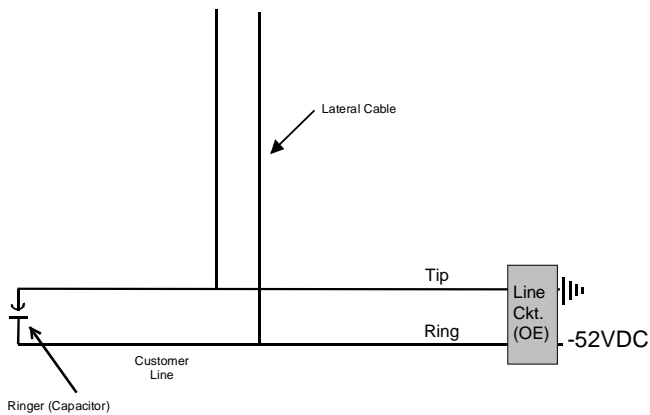
## Line OK

MLT has detected no major faults on the line, but the longitudinal balance was marginal (less than 60 DB but greater than 40 DB ).

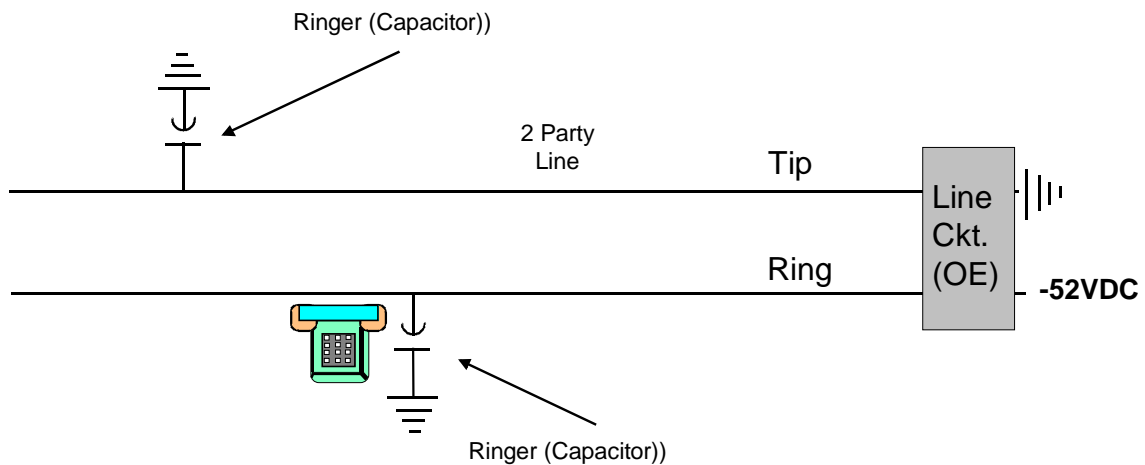
**VER GO -- VALID RINGER COUNT AND TERMINATION**

This VER code will only appear for the RINGER series test of MLT. It indicates that both the number of ringers\* and the arrangement of those ringers (T-R, T-G, or R-G) were what we expected to see according to the line records.

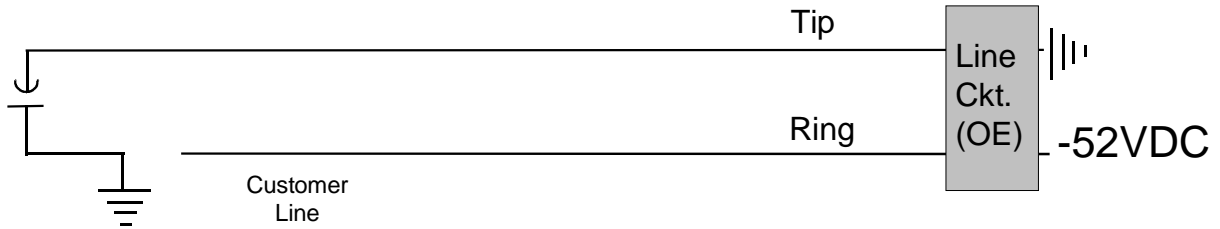
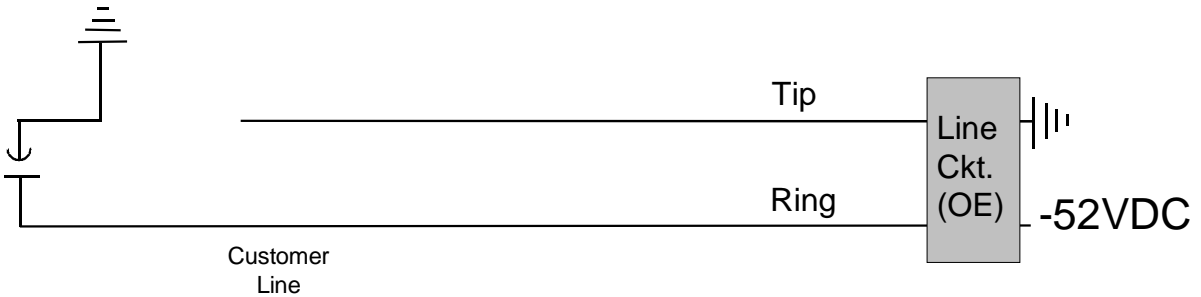
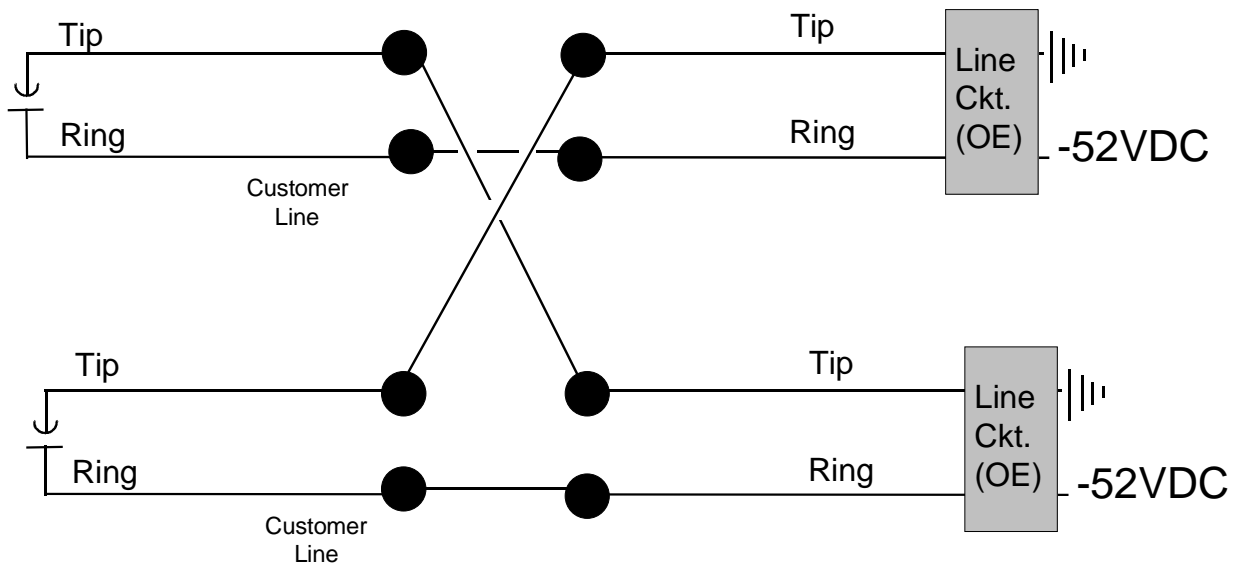
**VER G1 -- INVALID RINGER TERMINATION****1.**

This summary can appear in the FULL or LOOP series test as well as the RINGER series test.

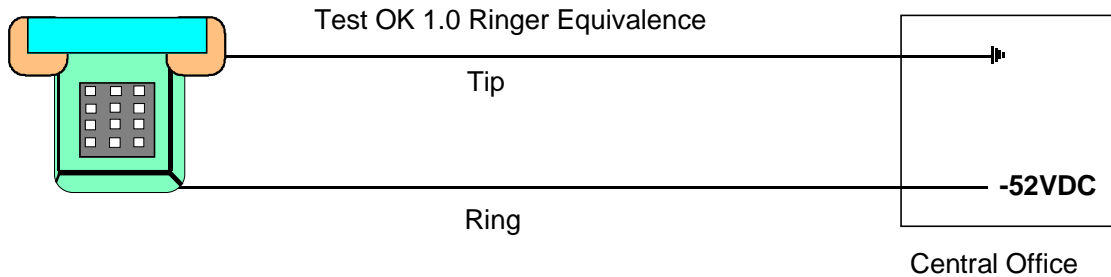
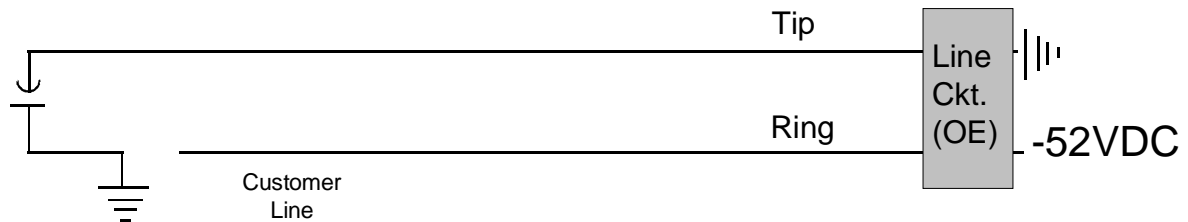
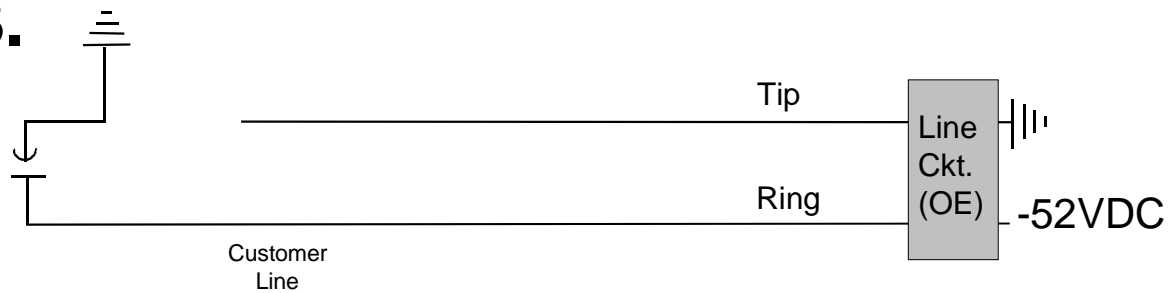
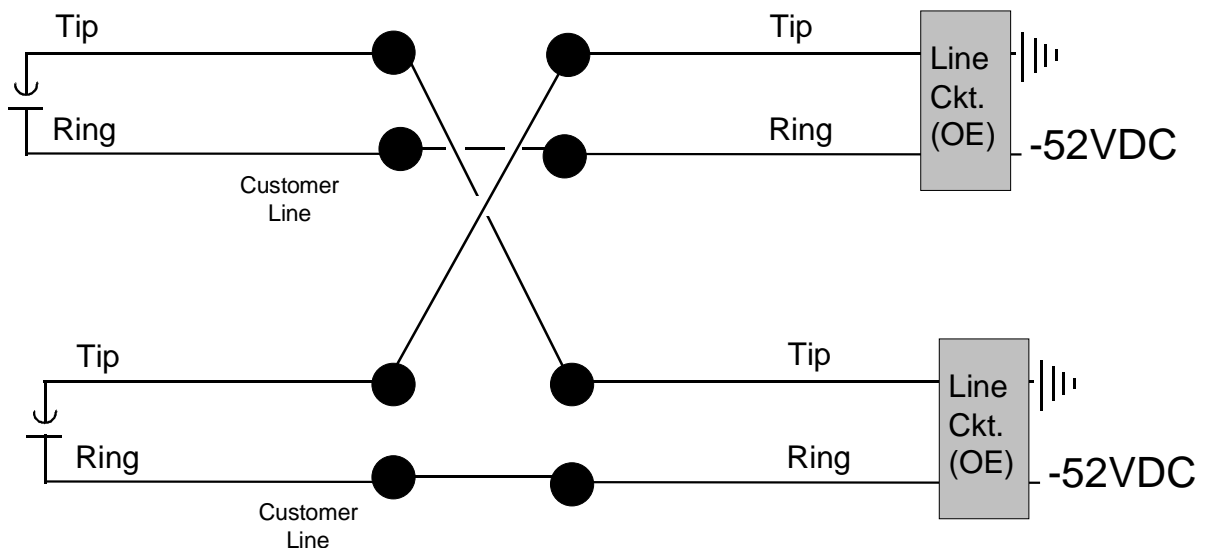
**VER G6 -- RINGER TEST - UNCATALOGED EQUIPMENT****1.**

This VER code will only appear following the RINGER request. It indicates that MLT ran the RINGER test on a line that had uncataloged equipment for the termination (UNCAT TERM in the TV mask TERM: field).

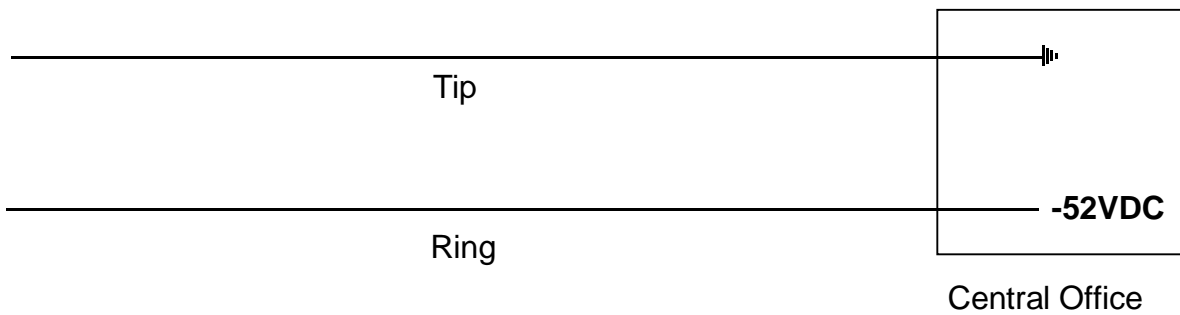
**VER G8 -- RINGER TEST - UNCATALOGED EQUIPMENT**

This VER code will only appear for the MLT Ringer series test. It indicates that no ringers were found even though there should have been ringers based on the line records. This result will **NOT** appear on a line with UNCAT TERM in the TERM field of the TV mask.

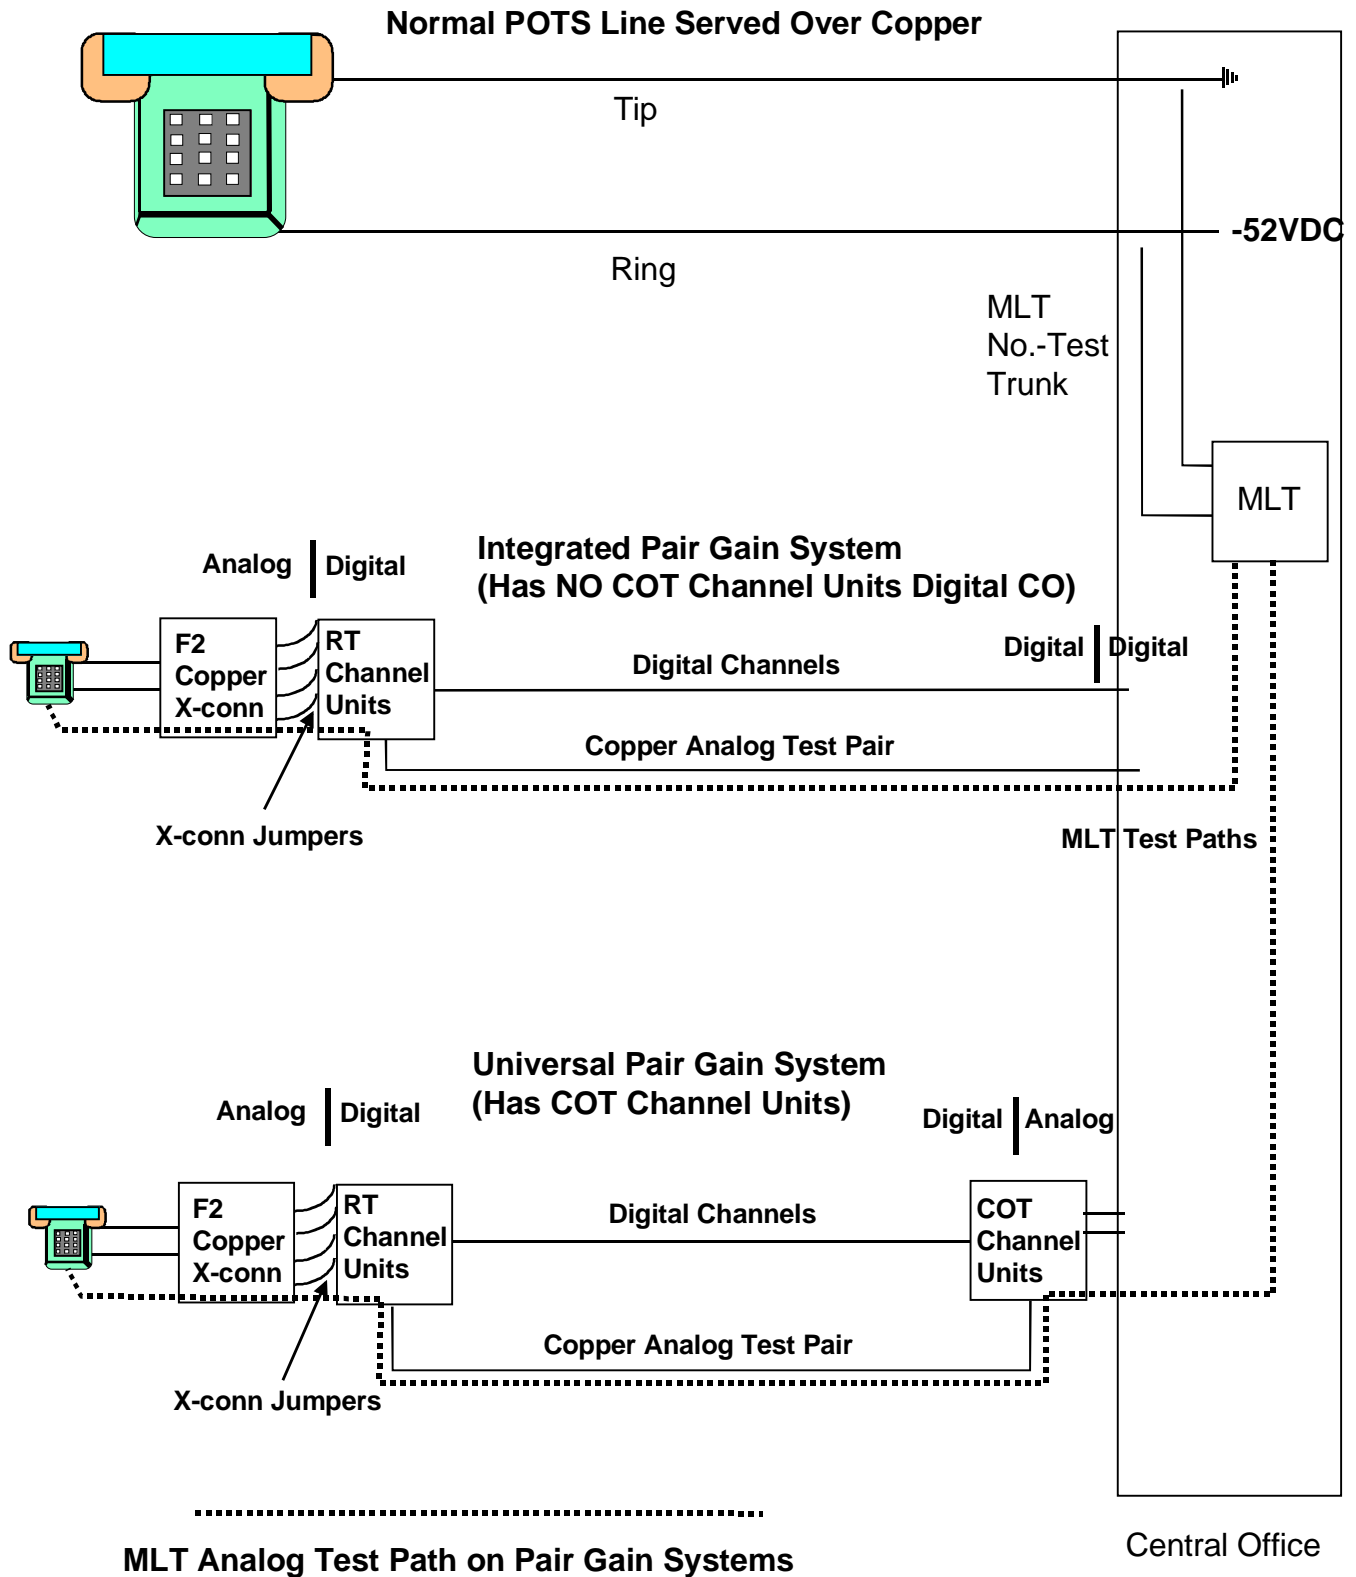
## VER U6 -- UNEXPECTED INTEGRATED PGS/UNEXPECTED UNIVERSAL PGS

**VER U6 -- UNEXPECTED INTEGRATED PGS/UNEXPECTED UNIVERSAL PGS**

MLT results indicate a discrepancy in the line record information and the MLT test results.

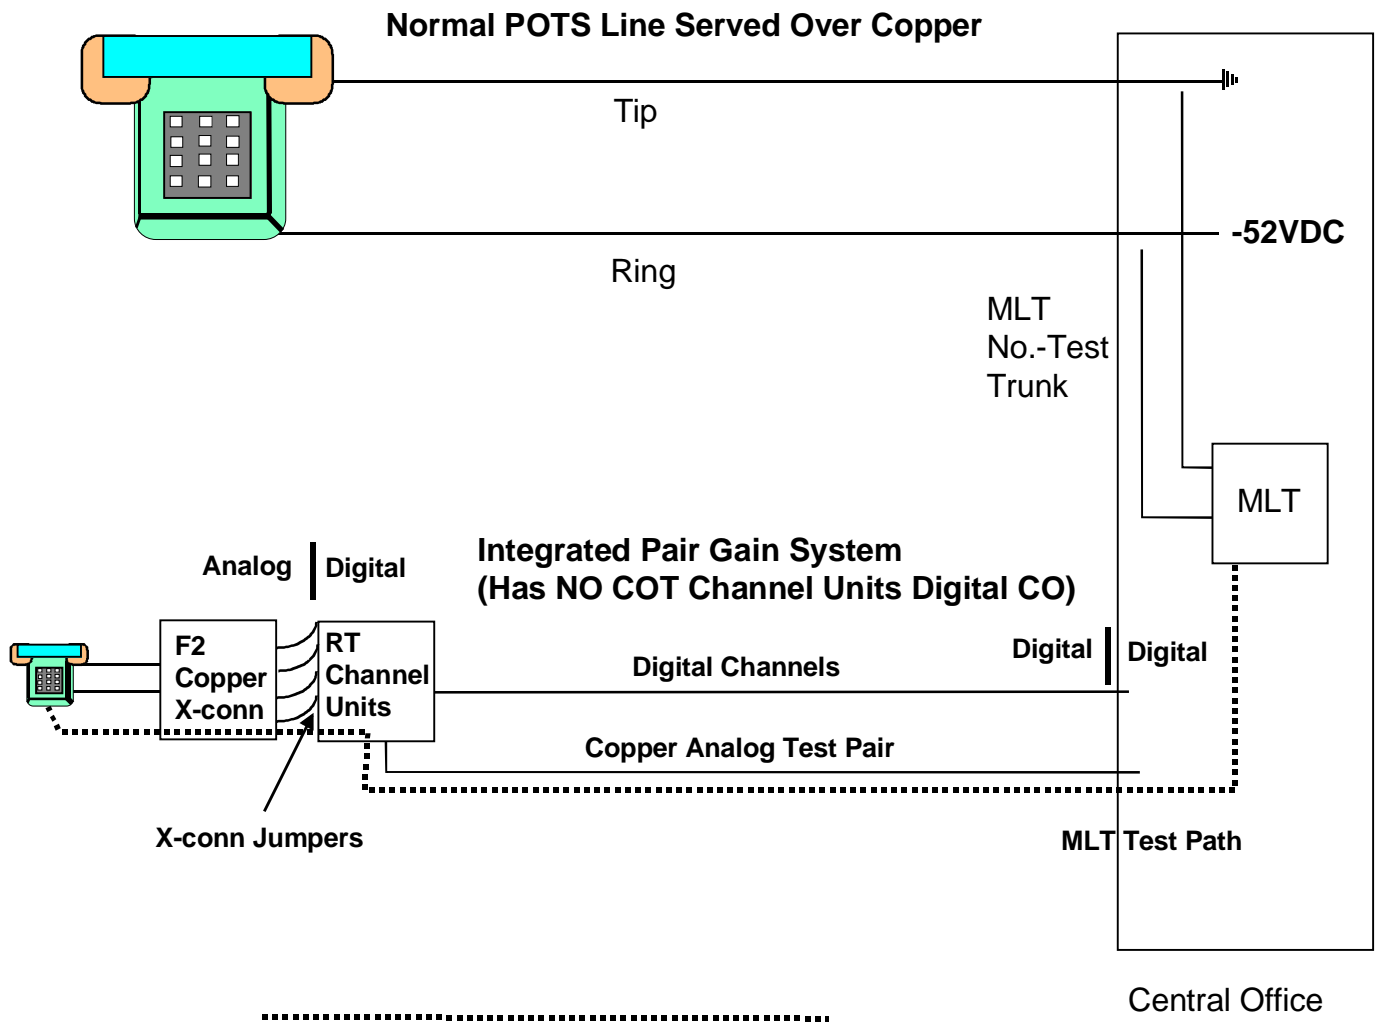
## MLT Analog Test Path on Pair Gain Systems

**VER 1P -- POSSIBLE INTEGRATED PAIR GAIN CHANNEL**

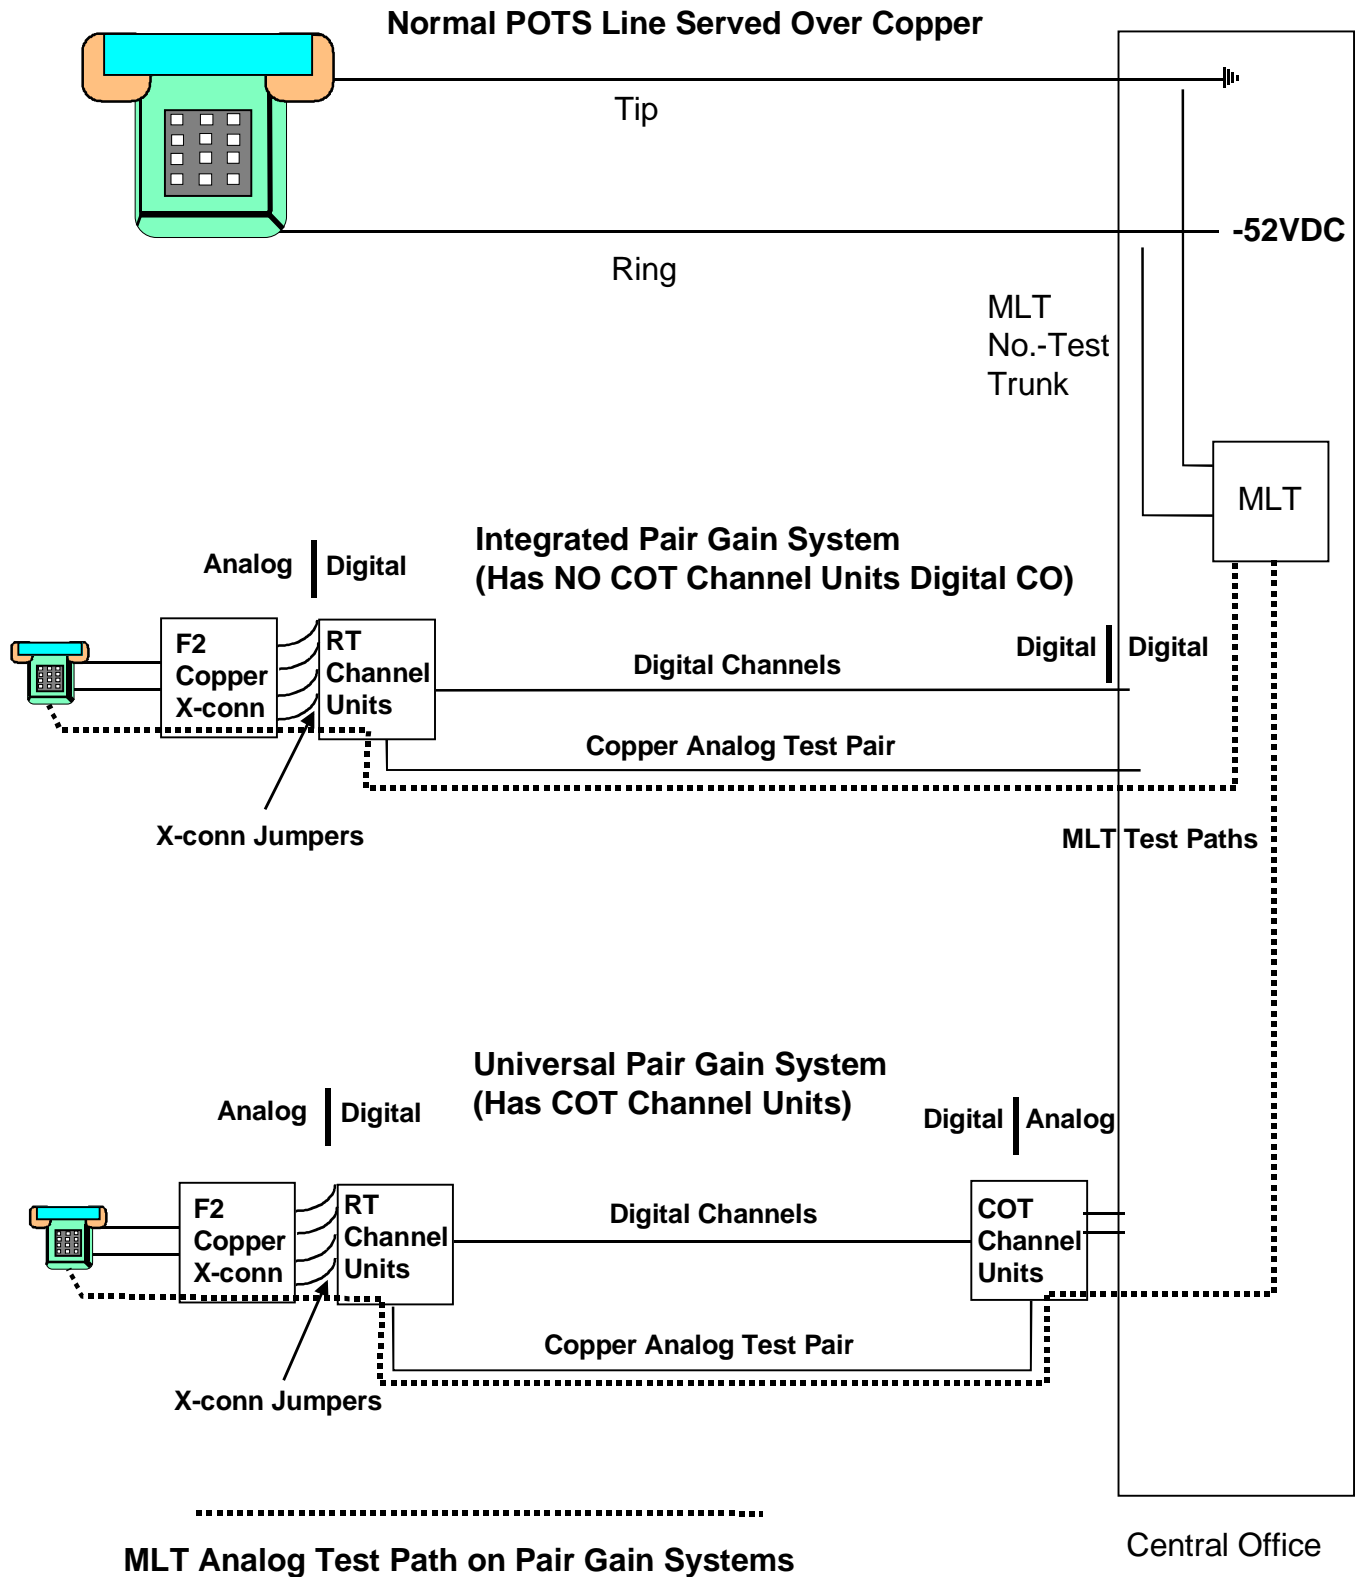
## VER 3P -- POSSIBLE PAIR GAIN CHANNEL UNIT FOUND

MLT has detected the possibility of a Pair Gain channel unit on the line. The MLT records do not indicate this customer's service is on a pair gain system.

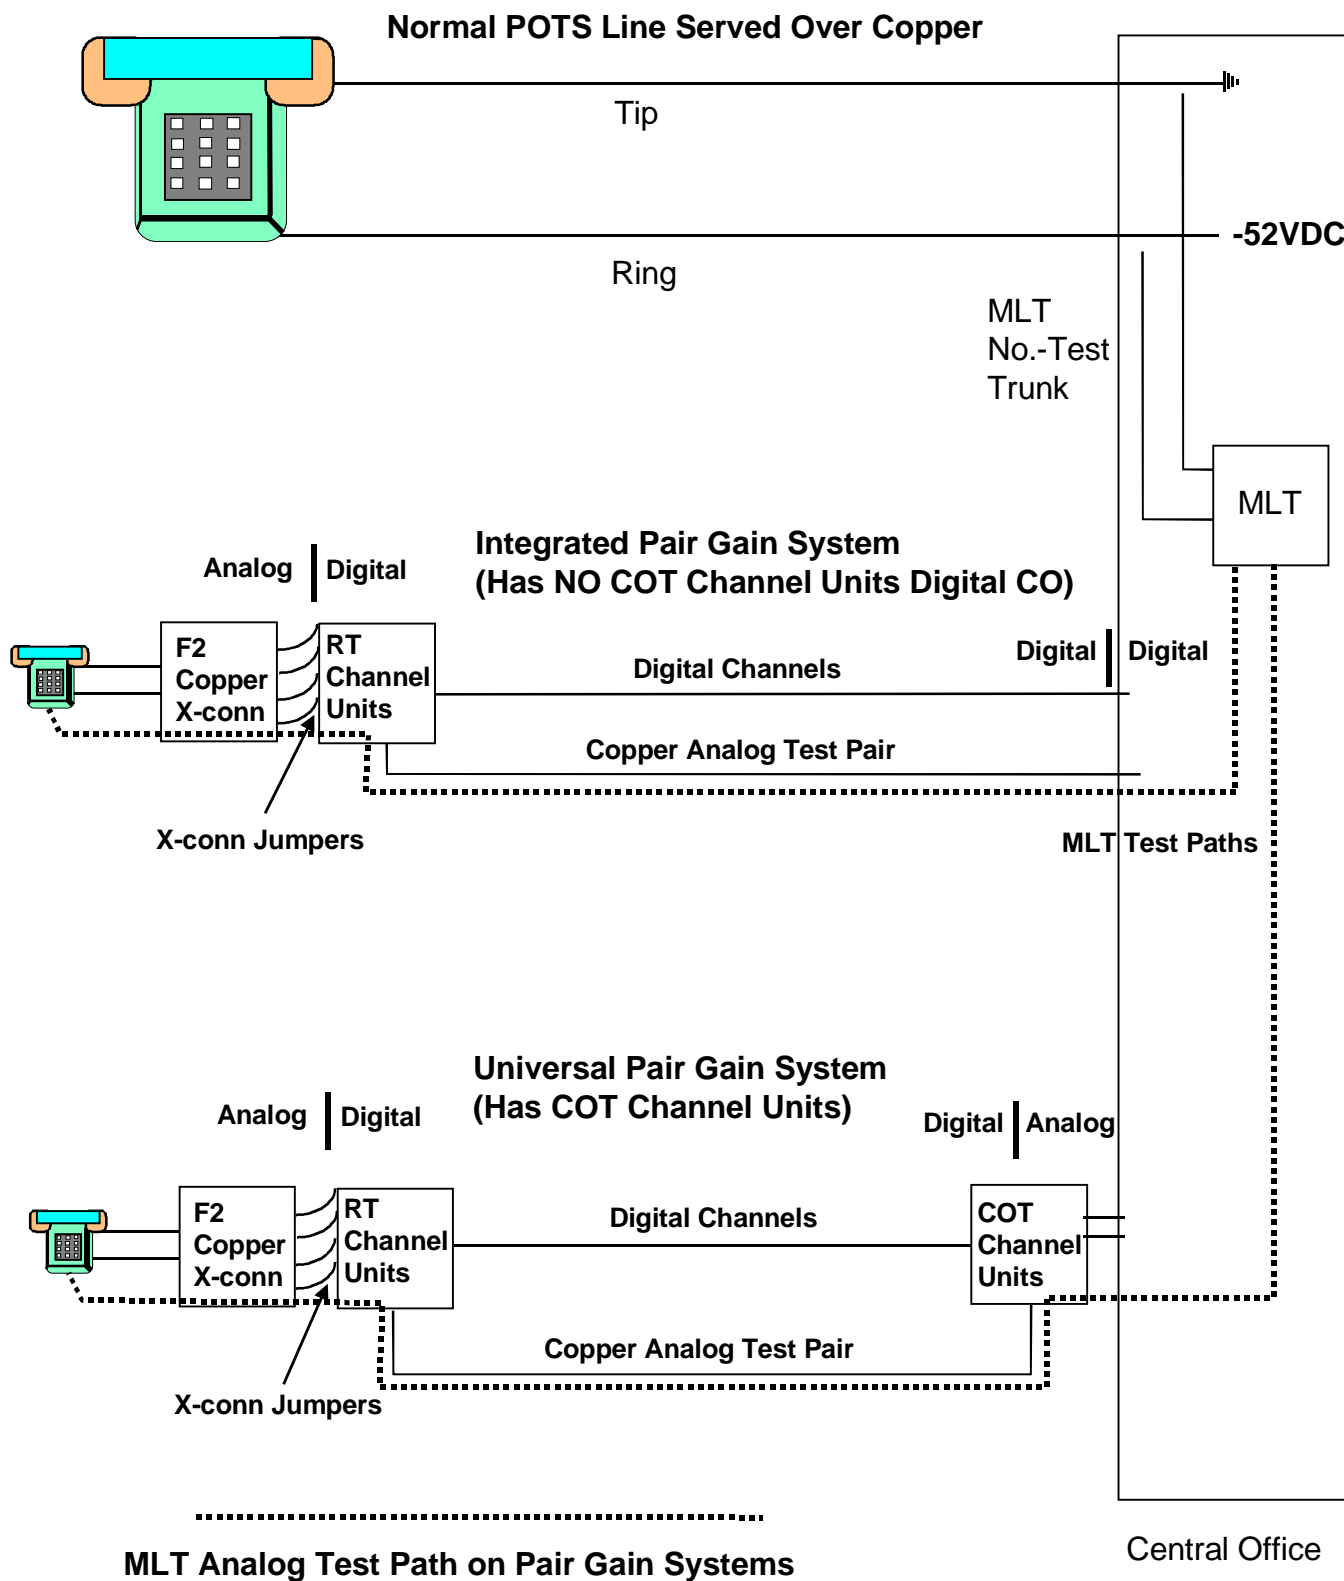
## VER 5P -- POSSIBLE PAIR GAIN CHANNEL UNIT FOUNND

MLT has detected the possibility of a Pair Gain channel unit on the line. The MLT records do not indicate this customer's service is on a pair gain system.

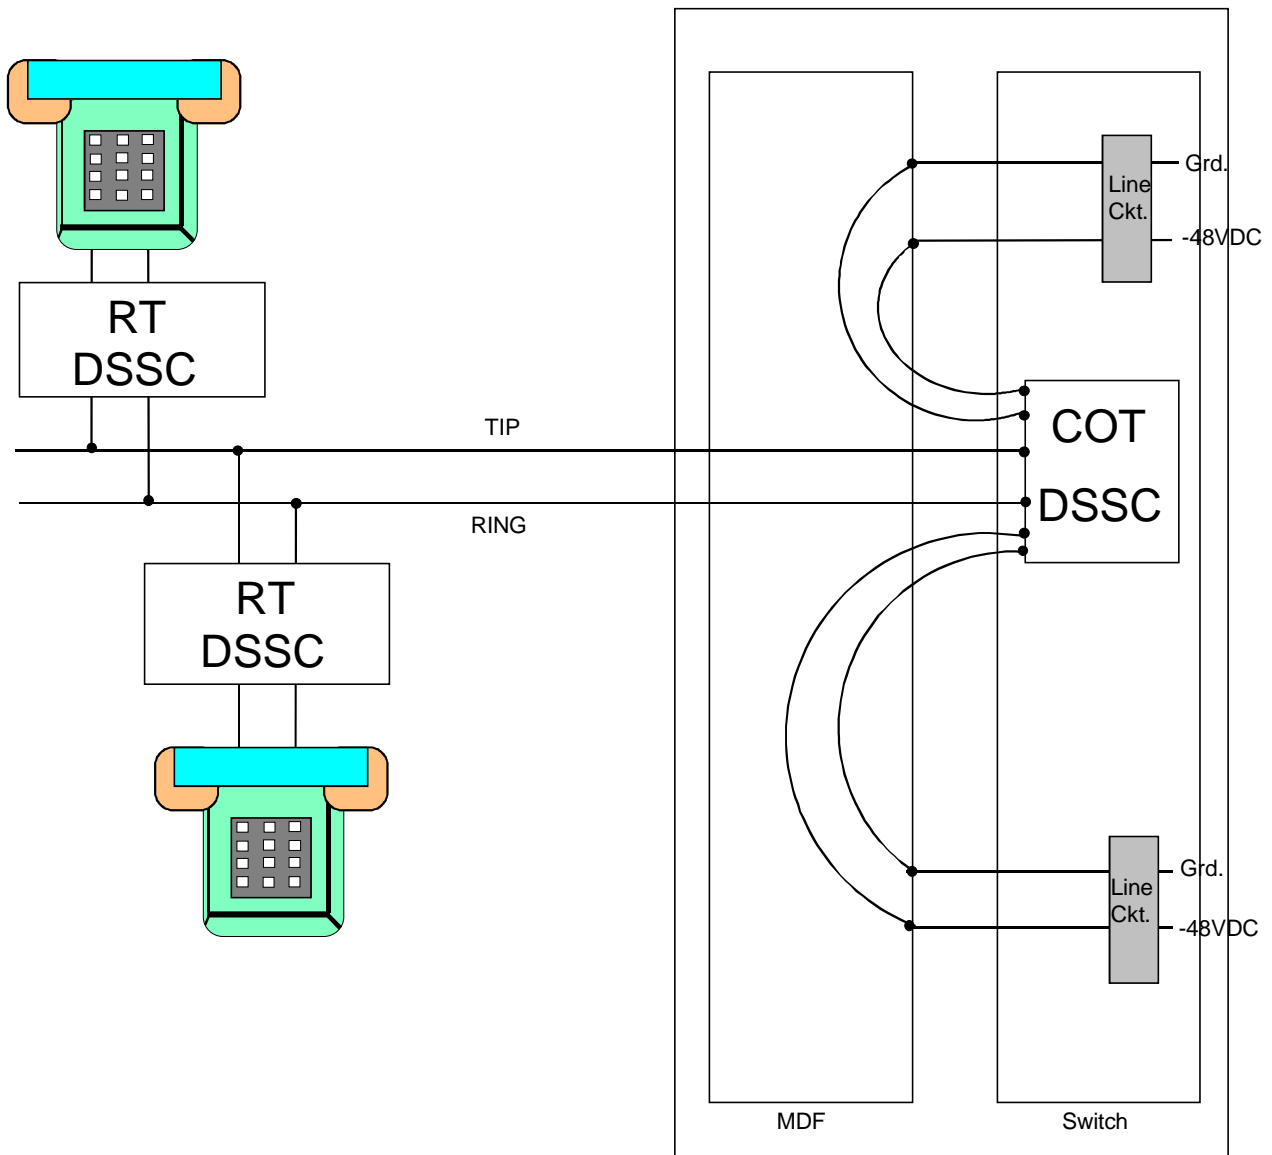
## VER 1R -- POSSIBLE RAYCHEM DSSC UNIT FOUND

**1R** - Possible RAYCHEM DSSC unit found - System Test OK.

SWBT uses some special types of carrier systems to provide telephone service when cable pairs are scarce. A digital single line subscriber carrier (DSSC) allows two customers to be served over one cable pair. Each customer is provided service over a carrier channel. MLT cannot perform tests through a carrier. The designers of the DSSC used in SWBT have provided electronic signatures that allow the MLT user to have a good chance to correctly identify and report major conditions of lines served by DSSCs.

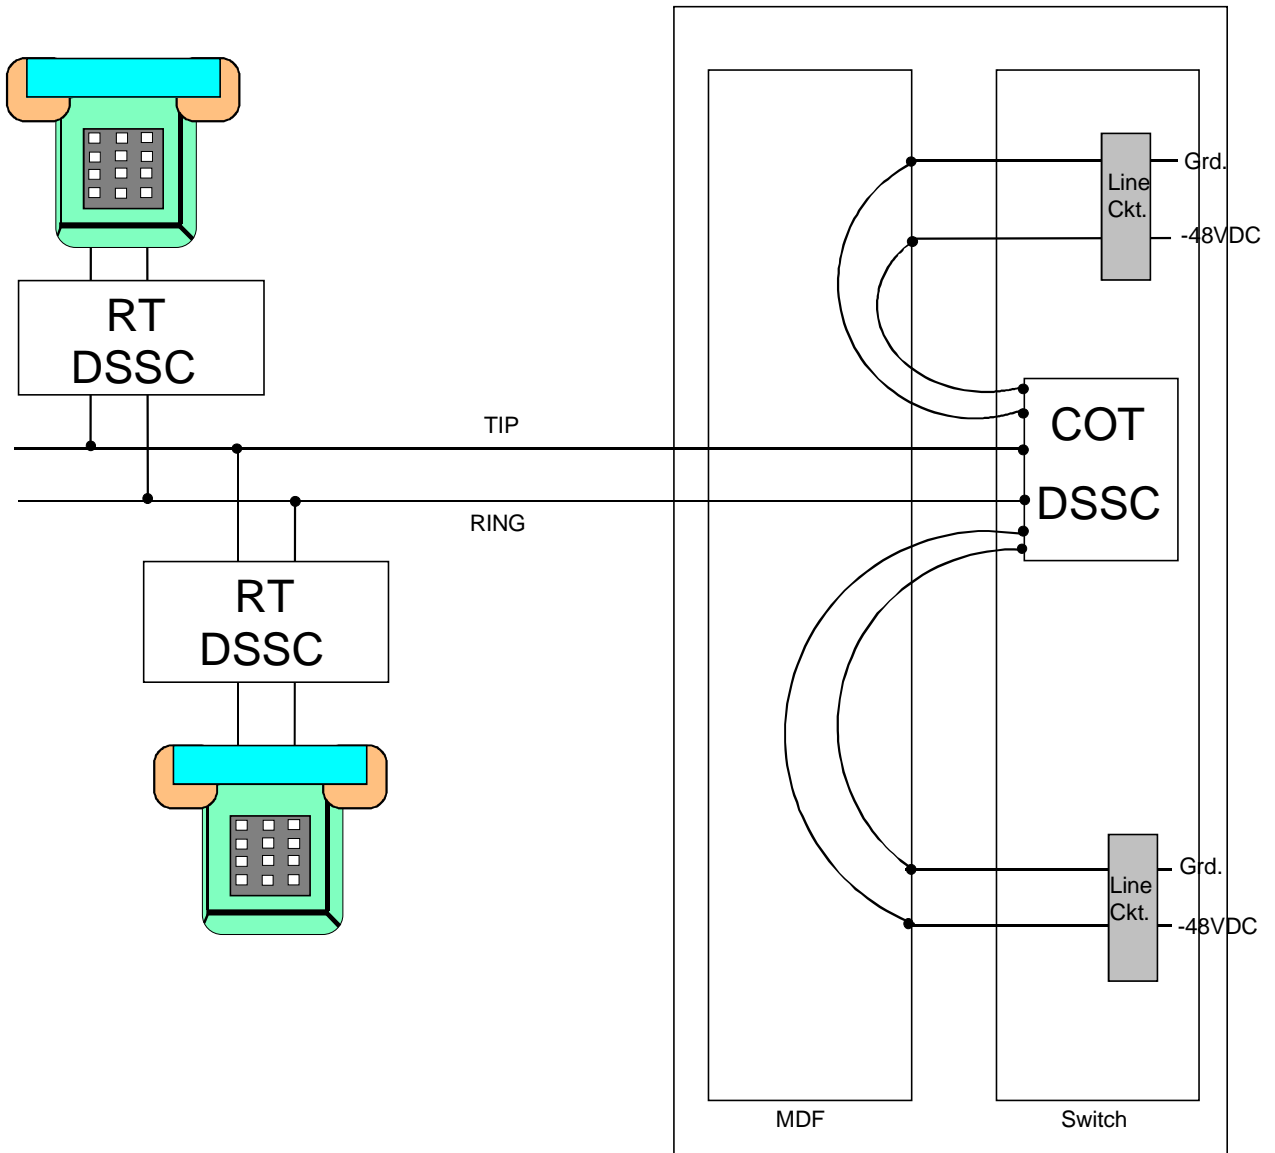
## VER 1W -- POSSIBLE WESCOM UDC UNIT FOUND

**1W** - Possible WESCOM DSSC unit found - System Test OK.

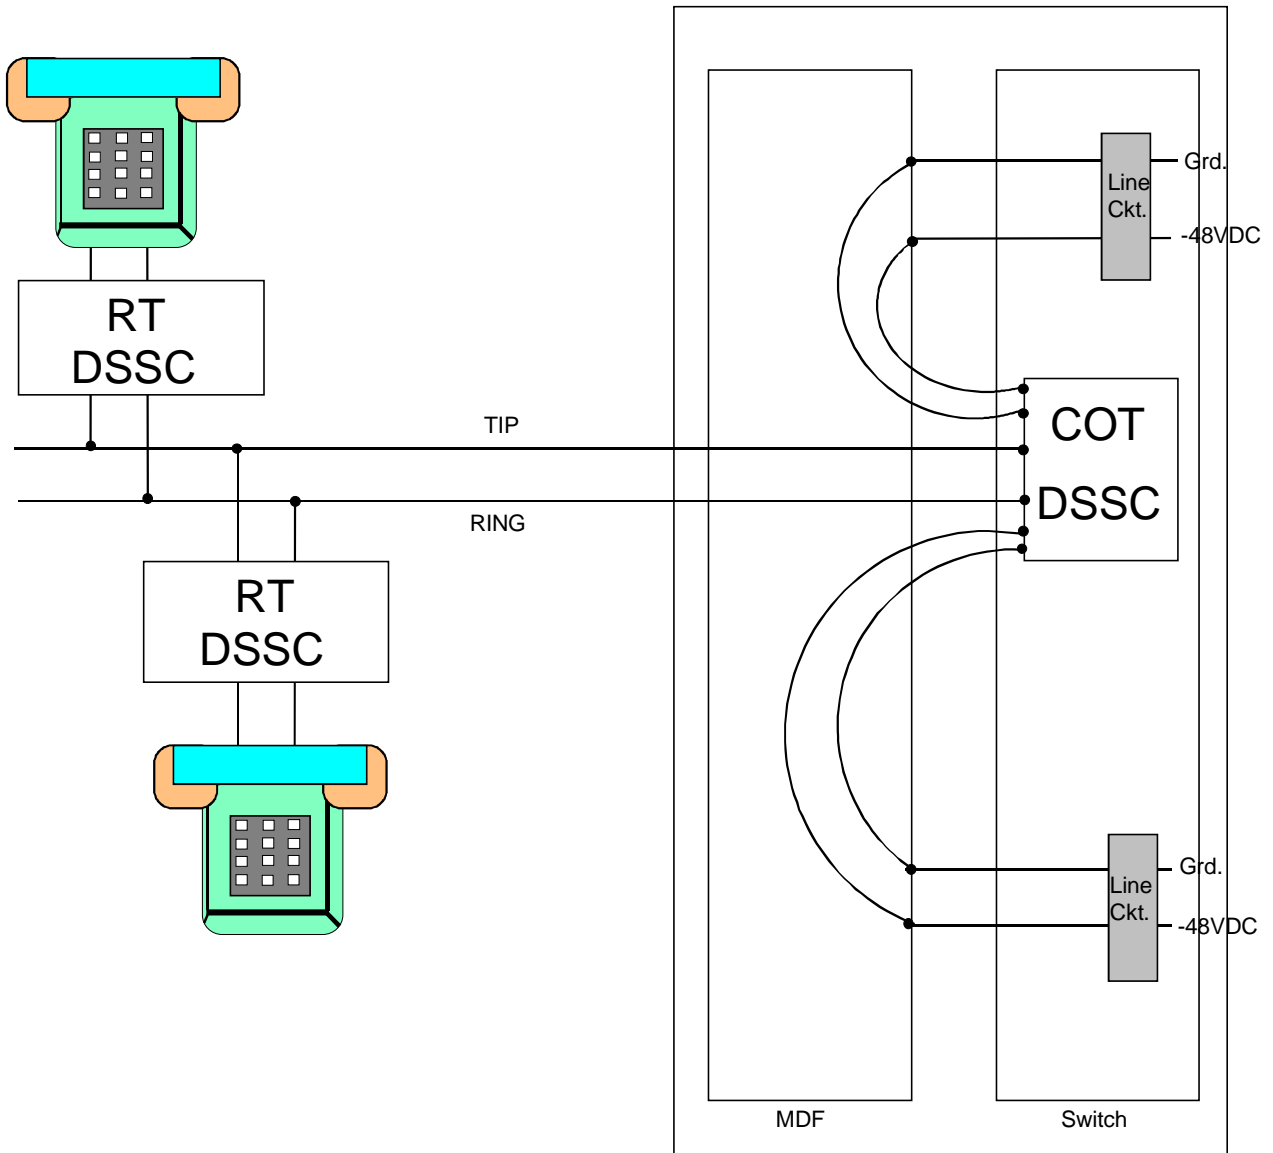
## VER 2W -- POSSIBLE WESCOM UDC UNIT FOUND

**2W** - Possible WESCOM DSSC unit found - RT System Failure - Dispatch to RT.
